RADYAS
Engineered Solutions

Project: Azadi Grand Hotel Tehran, Seismic Rehabilitation Design and Supervision. Tehran, Iran 2004 – 2010

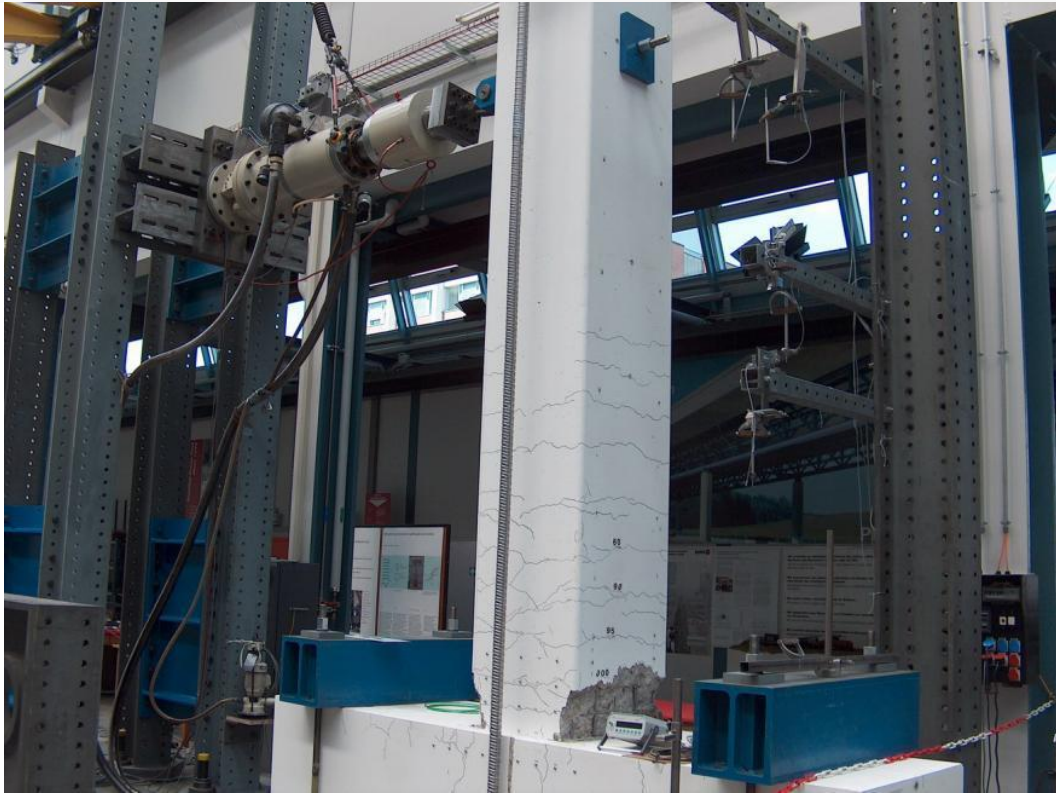
Prototype RC column to simulate Azadi Grand Hotel rectangular RC columns under cyclic earthquake load prior to design phase. Empa structural labs, Zurich, Switzerland 02/22/2005

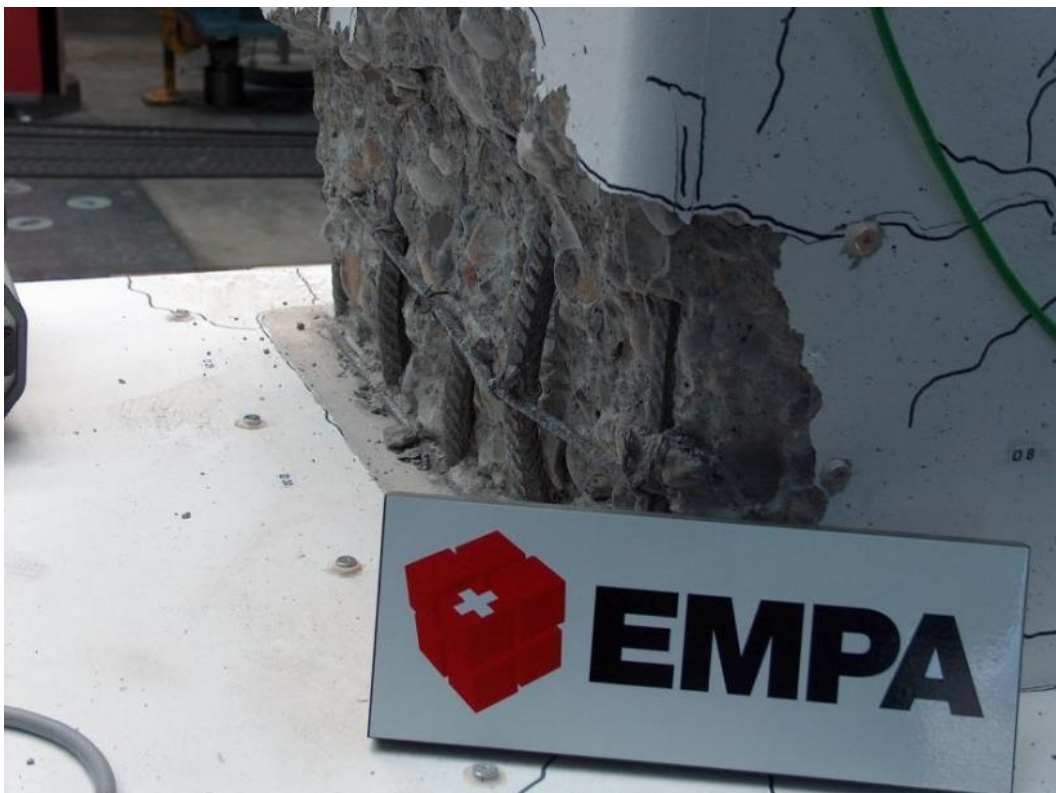
Test results shows compression rebars buckling under bending loads. Empa structural labs, Zurich, Switzerland 07/20/2005

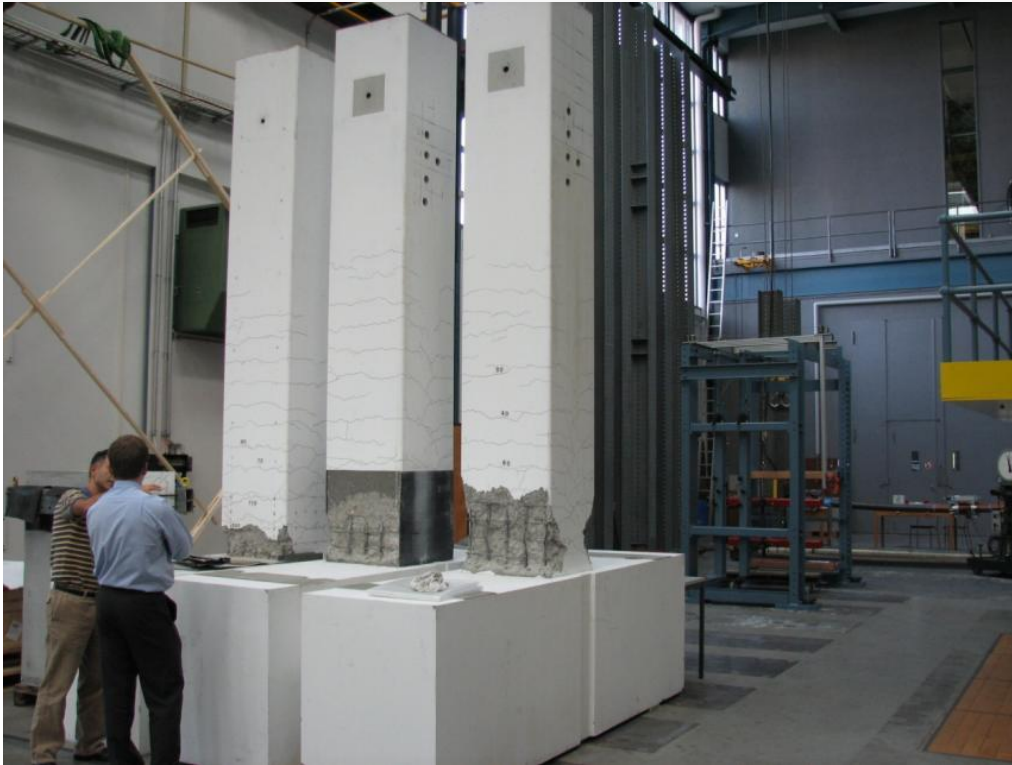
Three different prototype RC columns under cyclic earthquake load prior to design phase. Empa structural labs, Zurich, Switzerland 09/20/2006

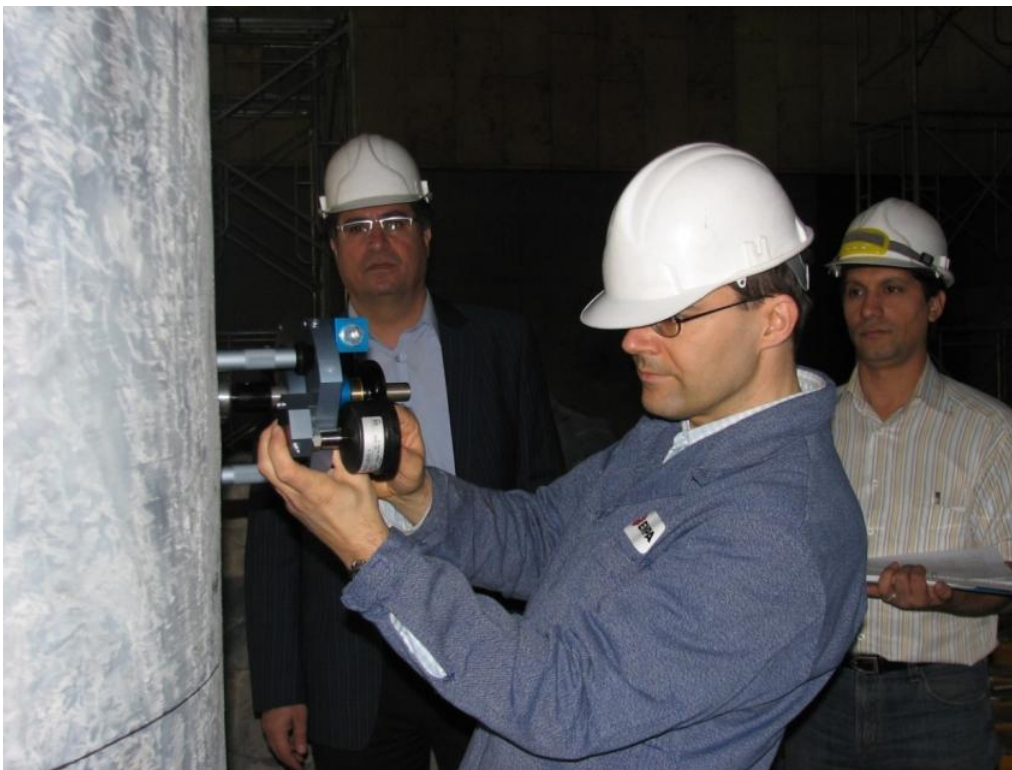
Pull off test to be carried out by Dr. Chrostoph Czaderski of Empa (middle), Mr. Javad Najafi (left). Tehran, Azadi Grand Hotel, 04/15/2008

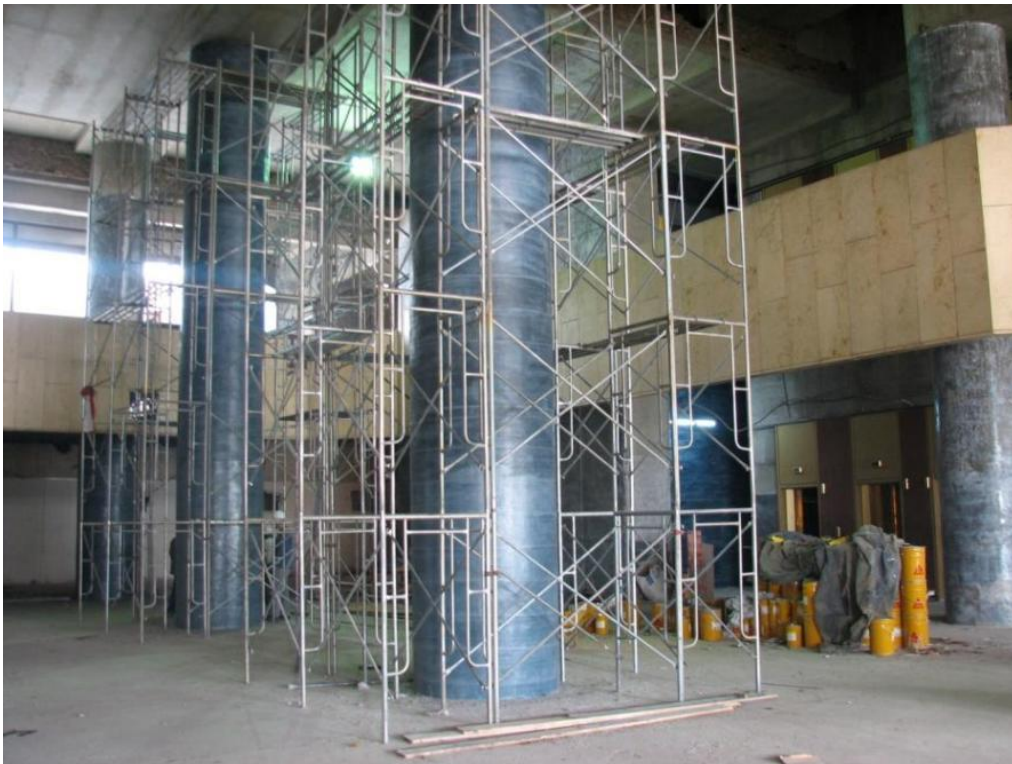
Azadi Grand Hotel Lobby. Main RC columns at the middle of the lobby are wrapped by Carbon fiber CFRP composites. Tehran 04/15/2008

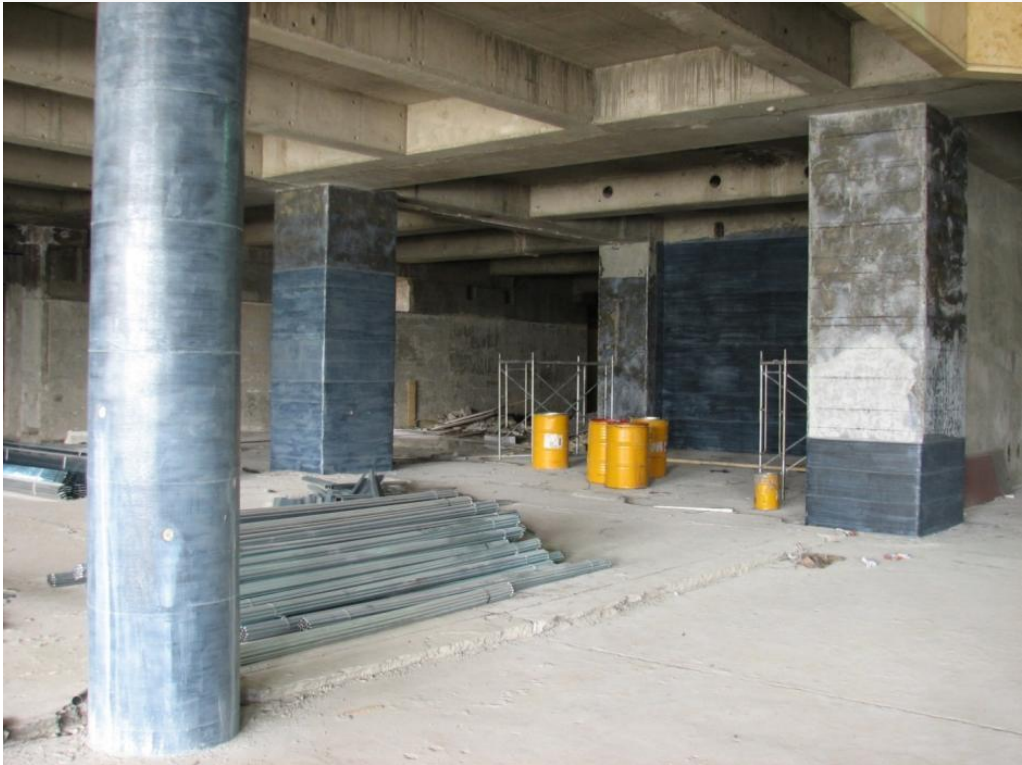
Interior RC columns are strengthened by Carbon Fiber CFRP Composite. 04/15/2008

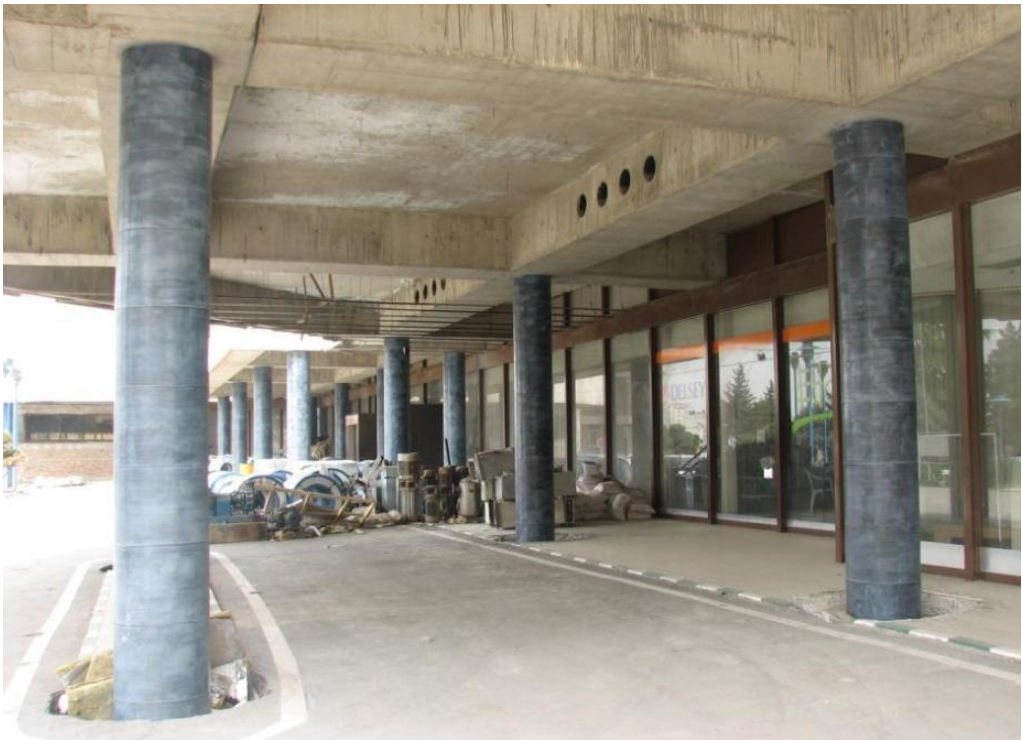
Exterior columns are strengthened by Carbon Fiber CFRP Composite. 04/15/2008

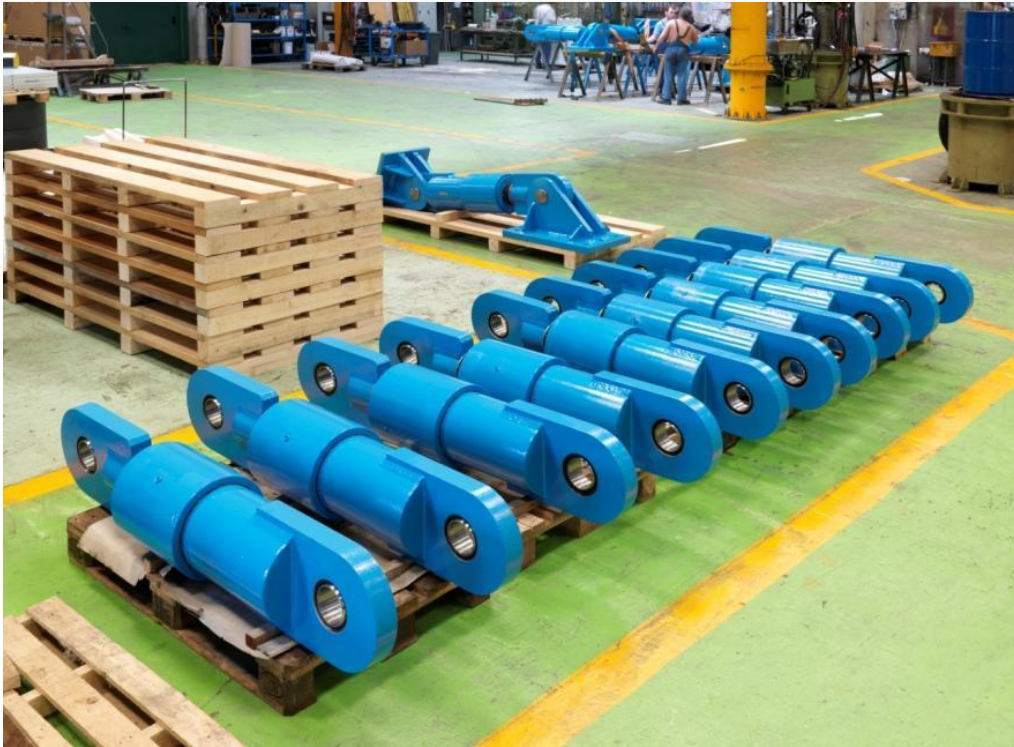
Hydraulic Dampers are ready to be shipped to Azadi Grand Hotel project in Tehran. FIP Industriale, Padova, Italy 07/03/2008

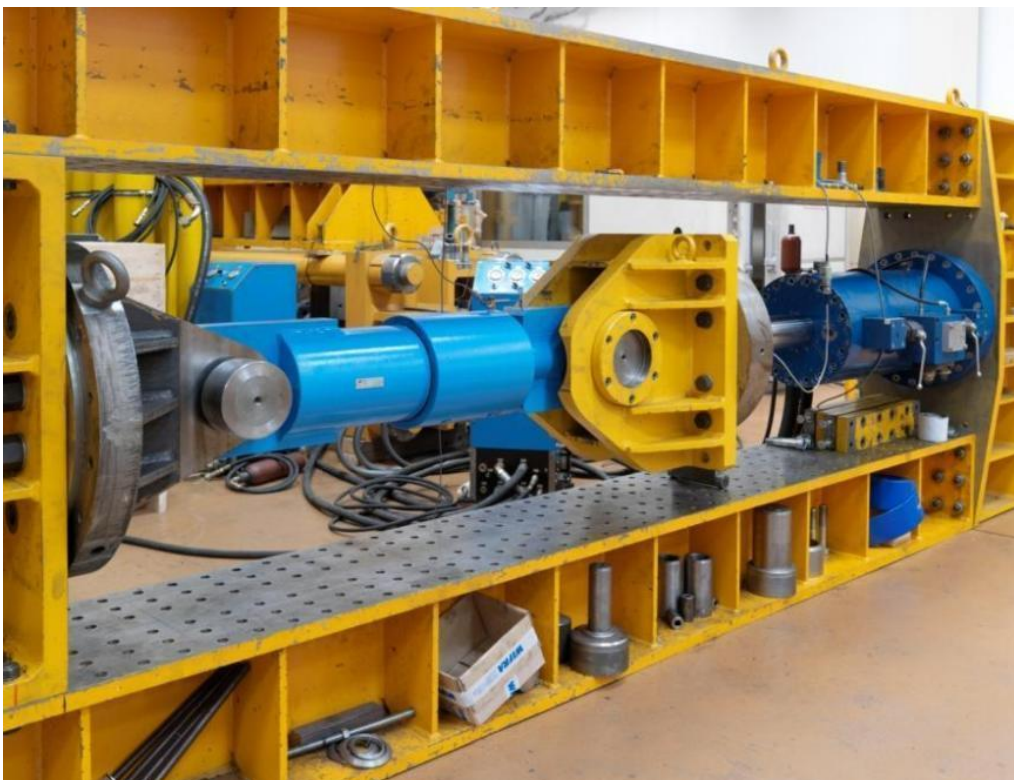
One of the hydraulic Dampers installed in the test setup to measure the technical characteristics under supervision of Swiss Federal Institute EMPA expert Dr. Felix Weber. FIP Industriale, Padova, Italy 07/03/2008

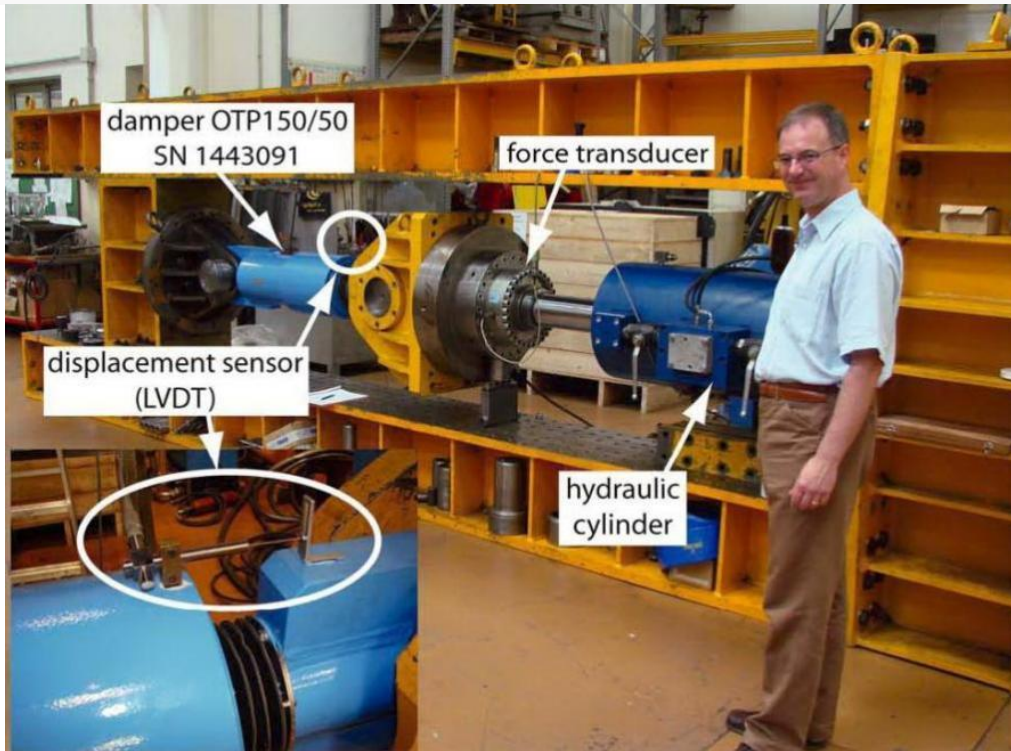
The hydraulic Damper installed in the test setup to be tested by Dr. Samuel Infanti of FIP Industriale under supervision of Swiss Federal Institute Empa expert Dr. Felix Weber. FIP Industriale, Padova, Italy 07/03/2008

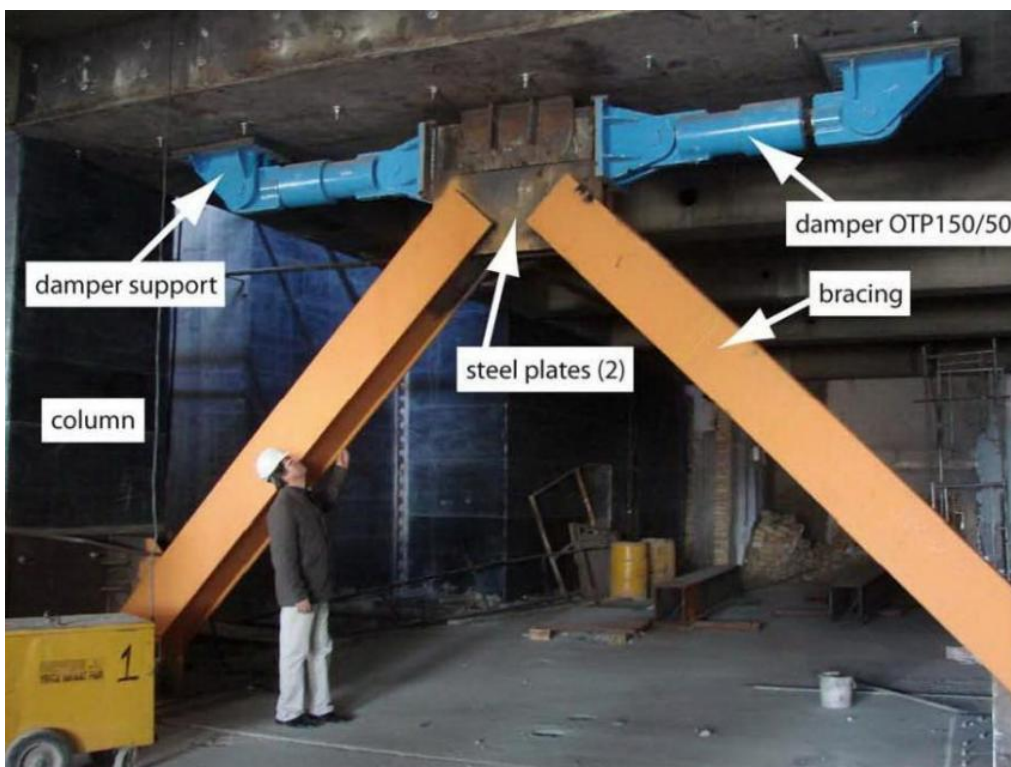
Hydraulic Dampers are installed in combination with the steel bracings. Mr. Javad Najafi is visiting installation of the energy damping system .Tehran, Iran 12/08/2008

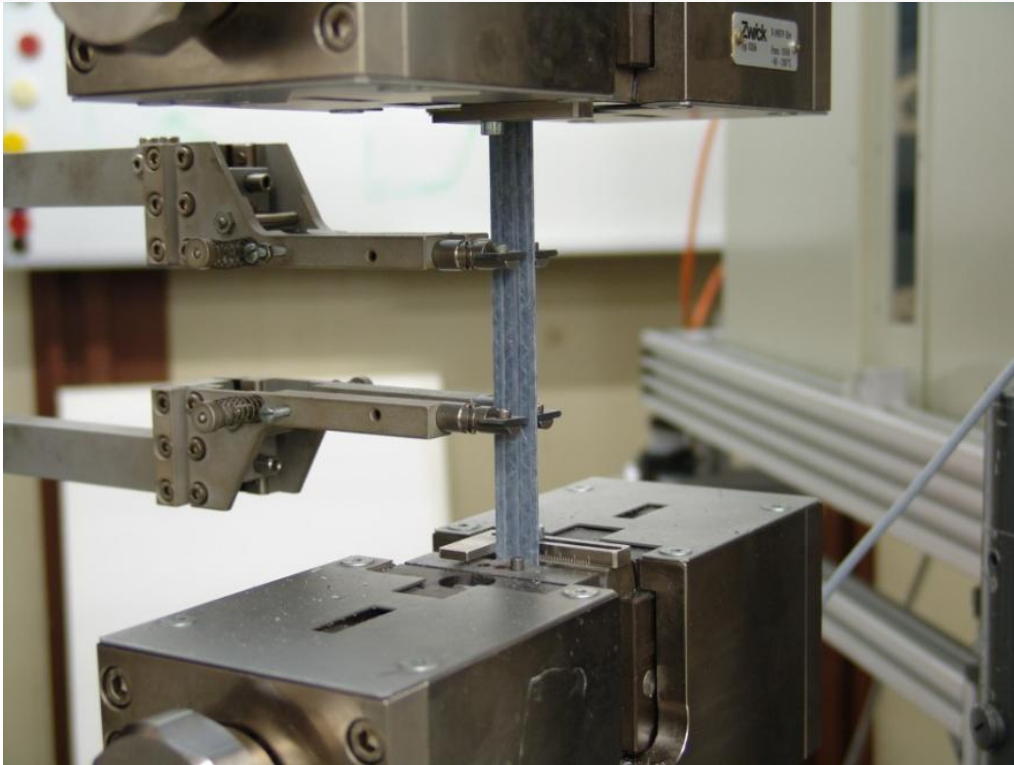
Carbon Fiber CFRP Composite samples under tensile test to determine tensile characteristics such as ultimate tensile strength and tensile elasticity modulus. Empa structural labs, Zurich, Switzerland 09/08/2008

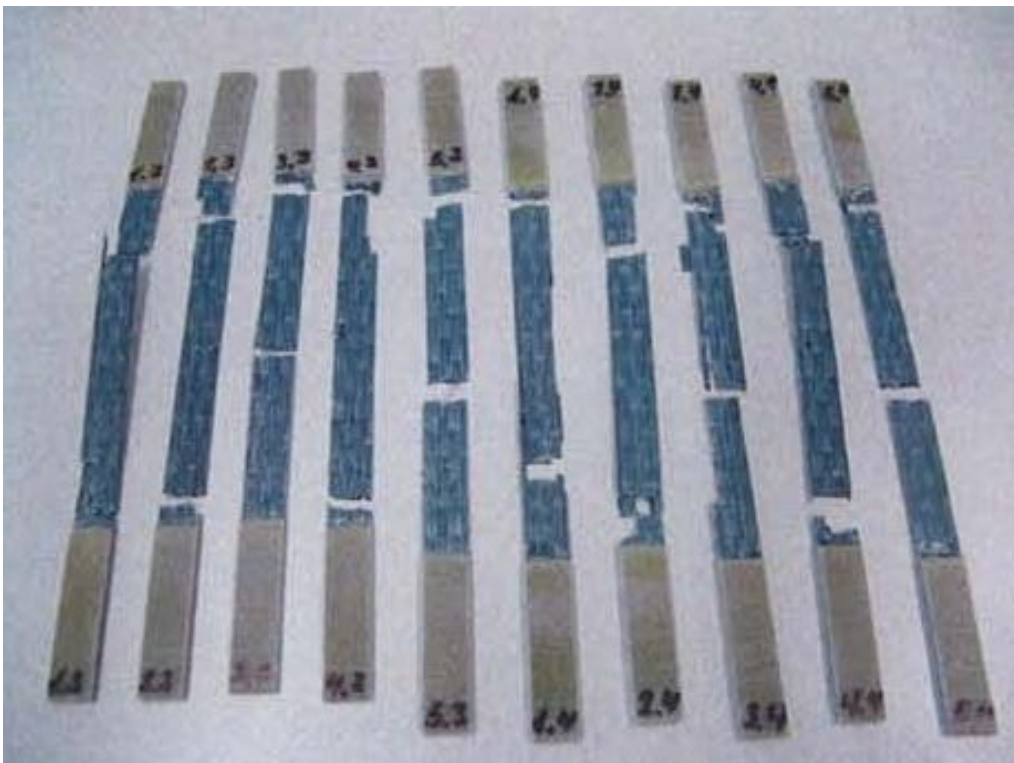
Carbon Fiber CFRP Composite samples after tensile test to determine tensile characteristics such as ultimate tensile strength and tensile elasticity modulus. Empa structural labs, Zurich, Switzerland 09/08/2008

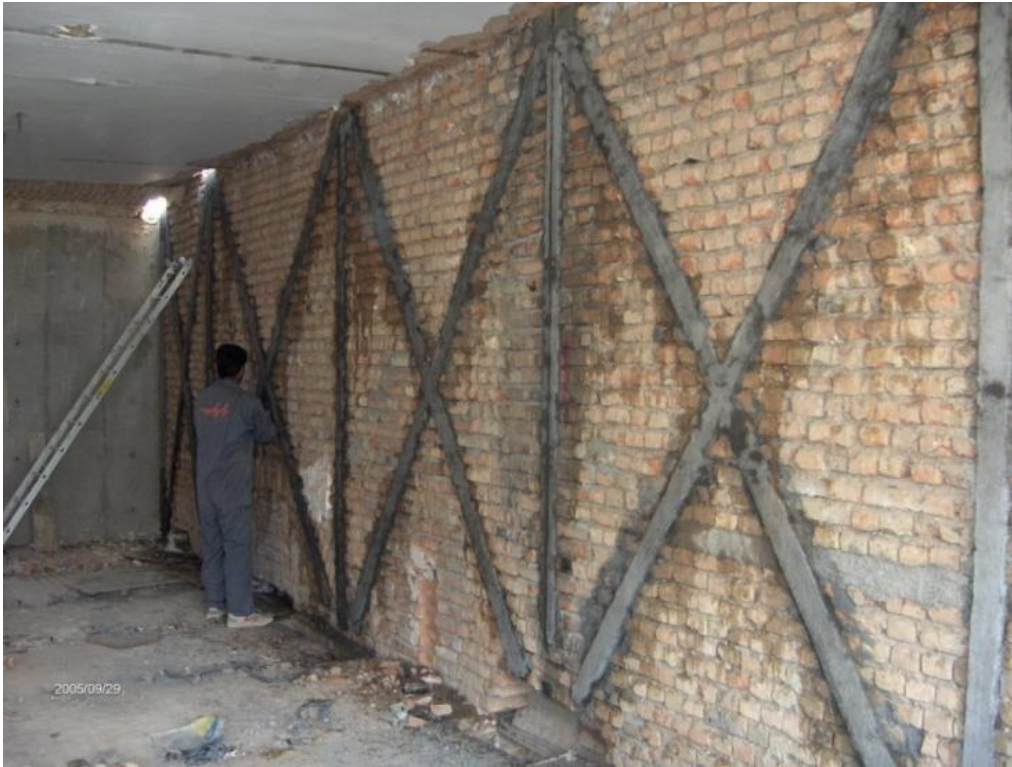
Radyab staff applying high strength repair mortar as substrate for CFRP stripes on the masonry walls. Shariati Museum, Tehran, Iran, 10/05/2005

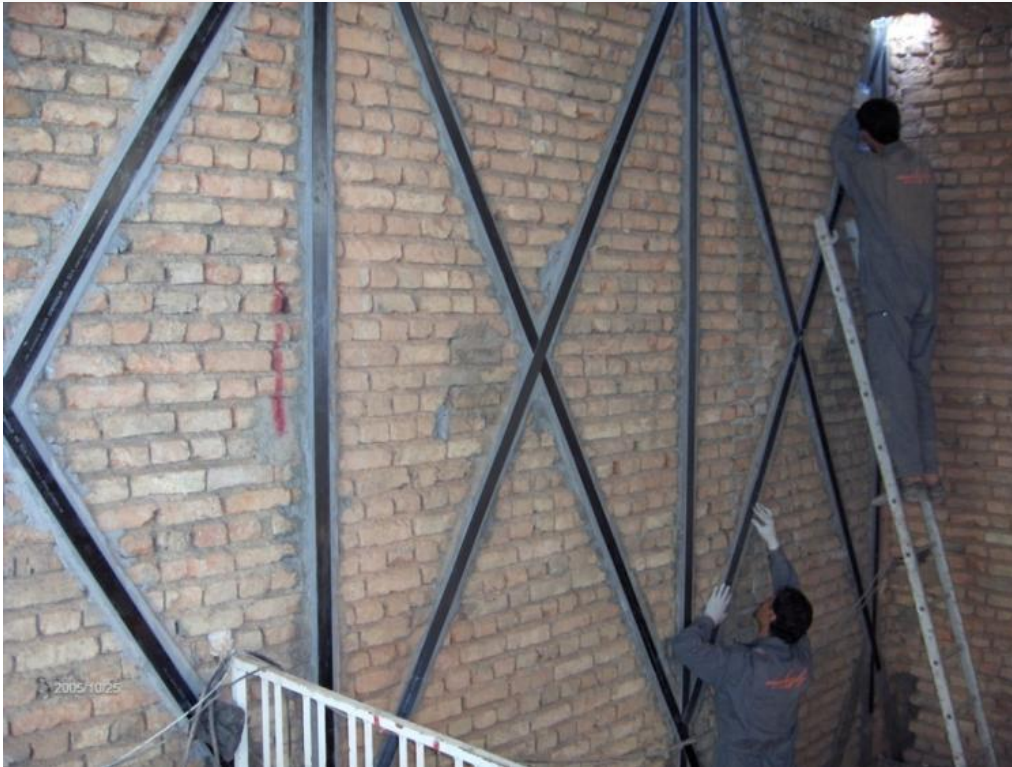
Radyab Co. staff applying CFRP stripes on the masonry walls. Shariati Museum, Tehran, Iran, 10/05/2005

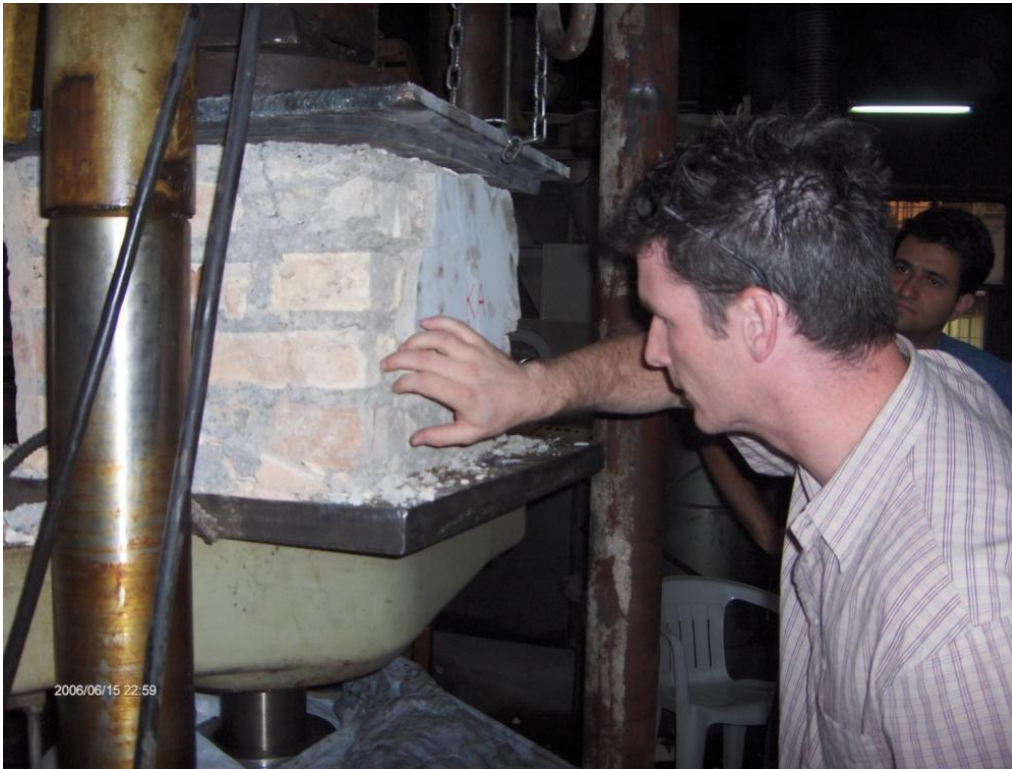
Compression test to be carried out on a masonry wall specimen taken out of load bearing walls in Swiss Embassy Building. Supervisor: Mr. Sven Heunert. Amirkabir University, Tehran 06/16/2006

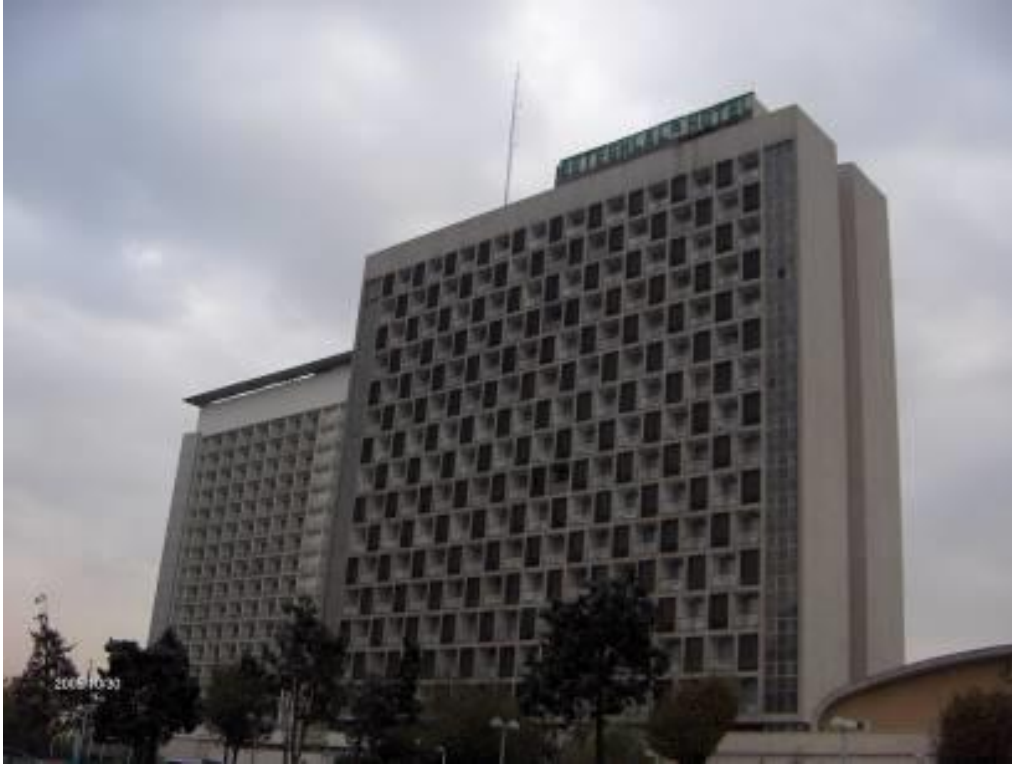
With a total area of 48000 m², west tower (right in the picture) is a 45-year-old steel structure and the east tower is a 35-year-old reinforced concrete structure.

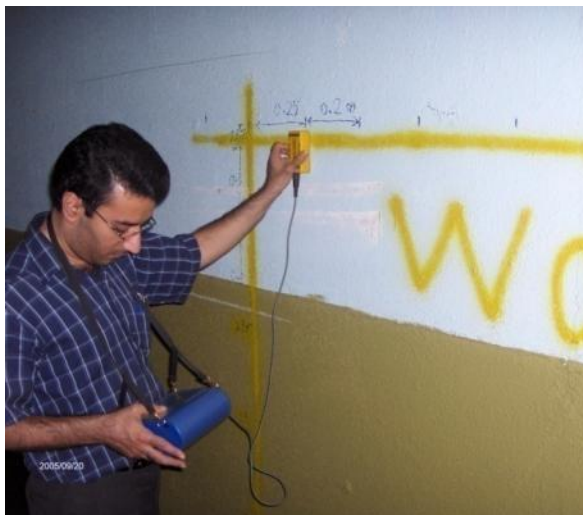
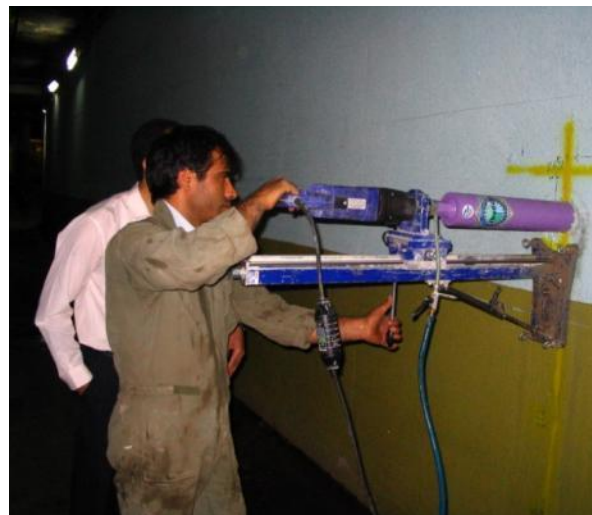
Non Destructive Tests (left) and Destructive Tests (right) to evaluate the existing structure. Radyab Co., Esteghlal Hotel, Tehran, Iran 09/20/2005

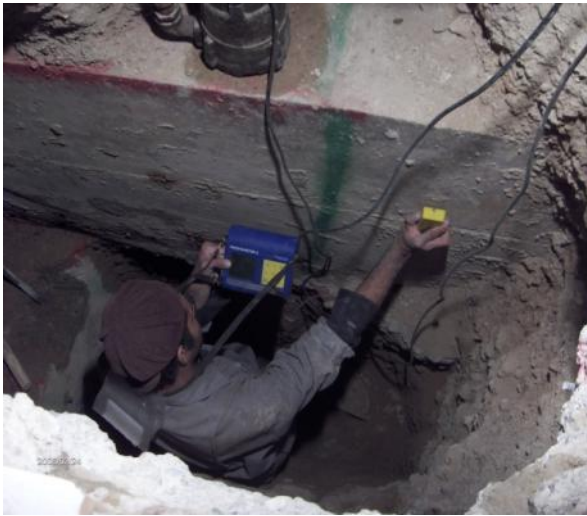
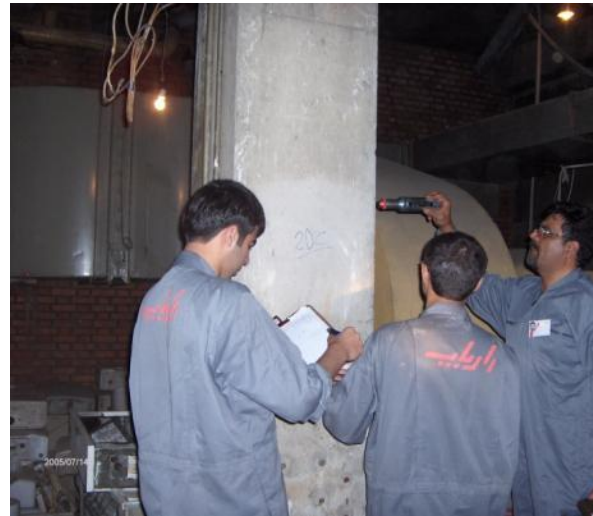
Non Destructive Tests to evaluate the existing structure. Left picture: Locating the rebars in the building foundation. Right picture: Determining concrete compressive strength by means of Schmidt Hammer. Esteghlal Hotel, Tehran, Iran 07/14/2005

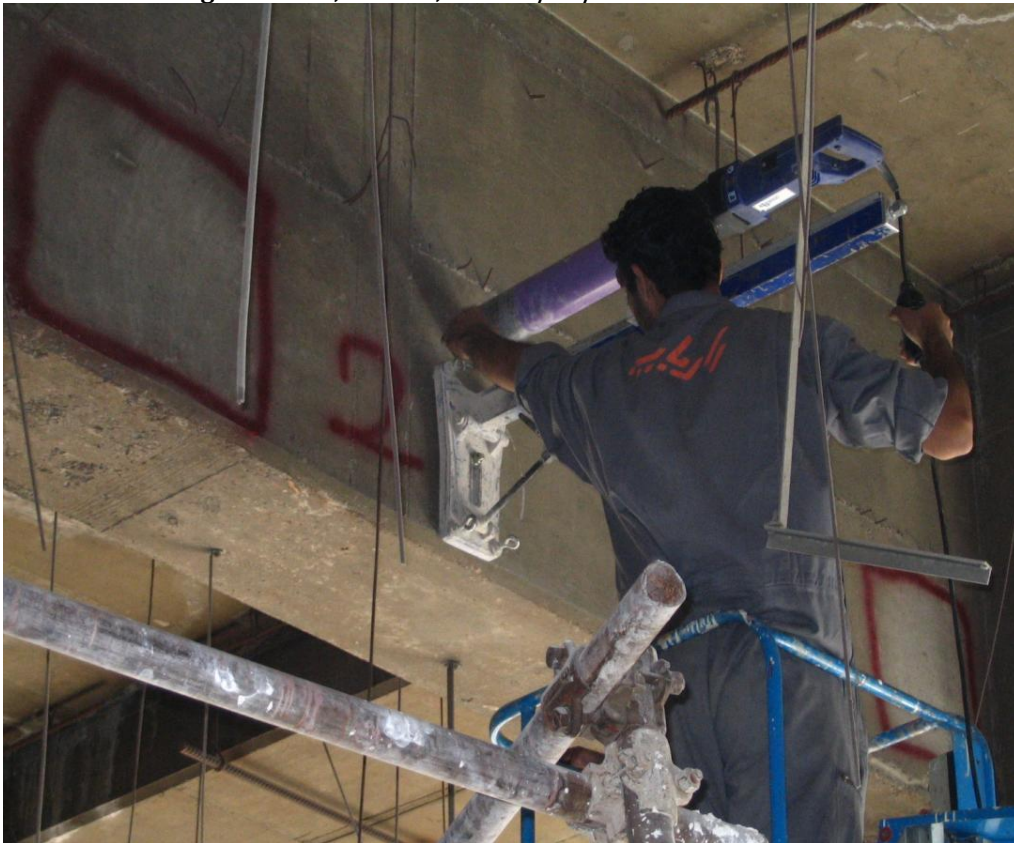
Destructive Tests (concrete core) on the RC beams to evaluate the existing structure material properties. Radyab Co., Esteghlal Hotel, Tehran, Iran 11/02/2005

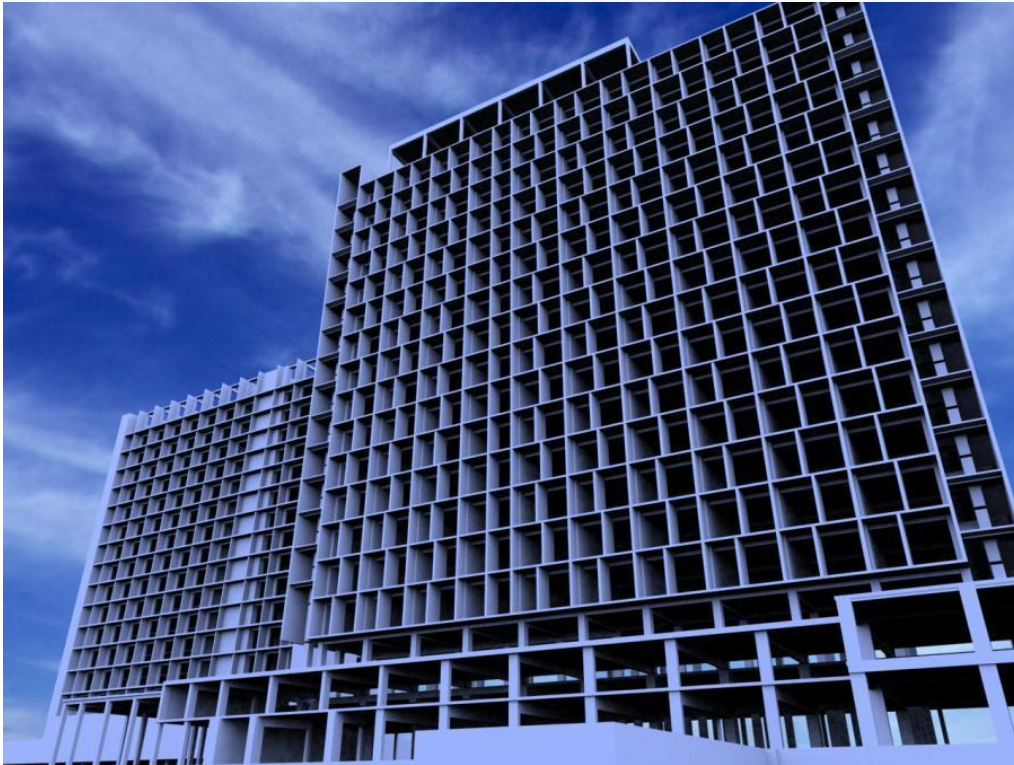
As Built 3D Structural Model of the building based on the detailed study is provided for Dynamic Analysis of the building in ADINA program. Radyab Co. Tehran, 2005

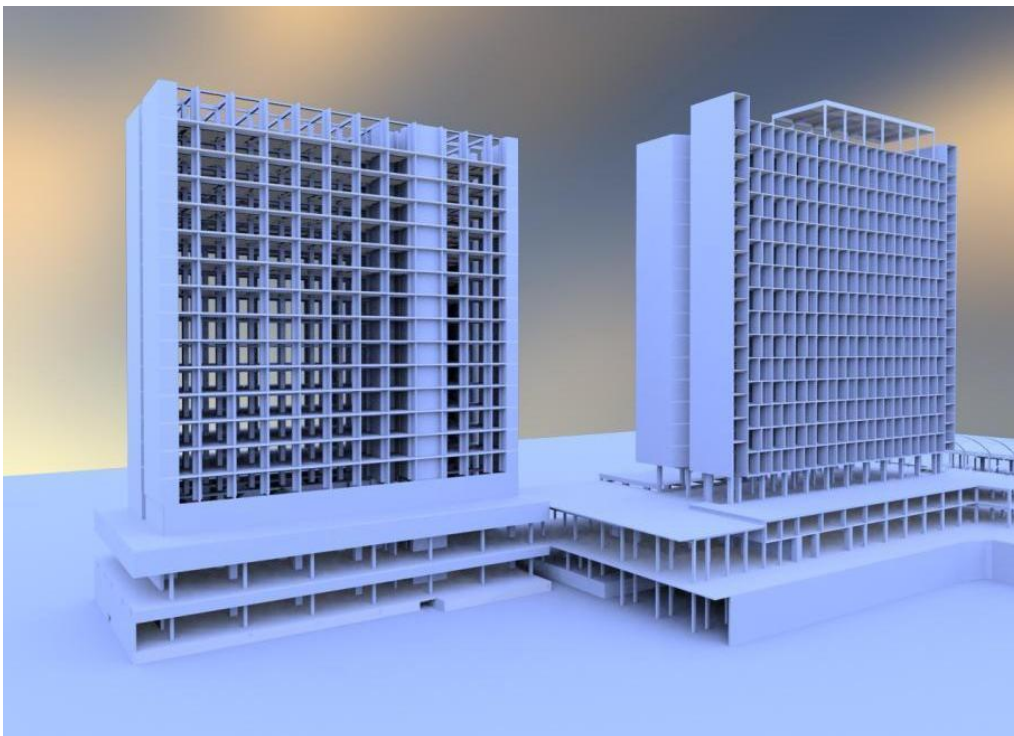
As Built 3D Structural Model of the building based on the detailed study is provided for Dynamic Analysis of the building in ADINA program. Radyab Co. Tehran, 2005

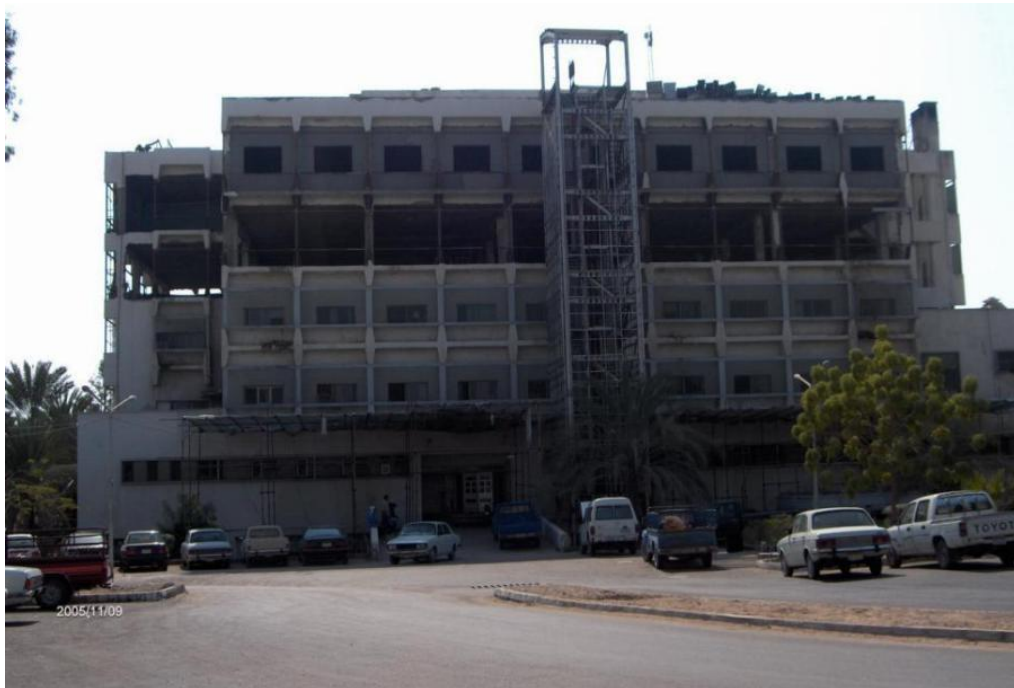
The two upper stories are to be refurbished and renovated while the other floors are operational. Bandar Abbas, Iran 11/09/2005

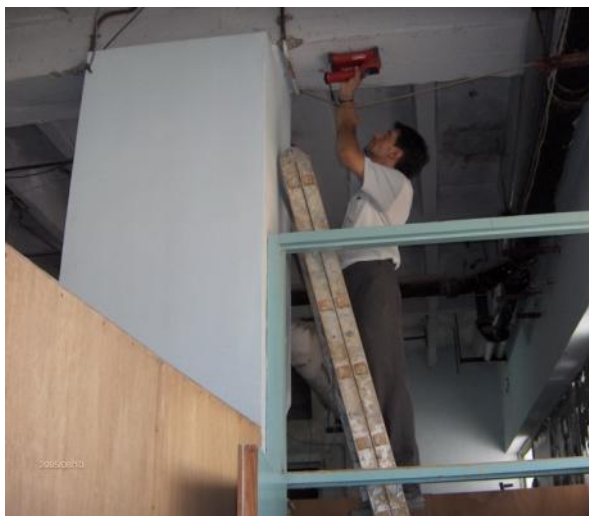
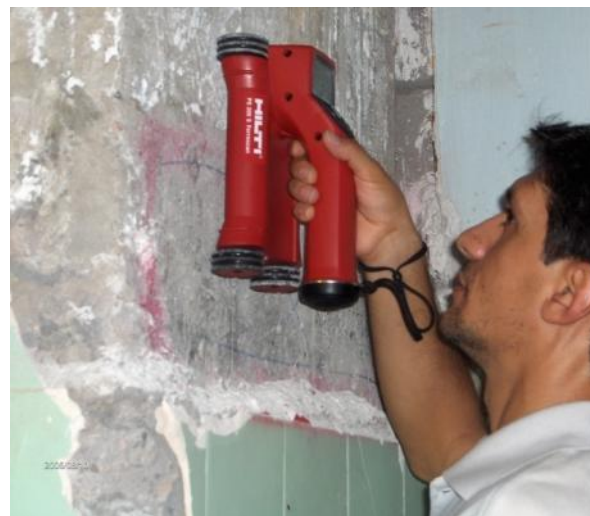
Non Destructive Tests to evaluate the existing structure. Staffs locating the rebars in the structural elements. Bandar Abbas, Iran 10/08/2005

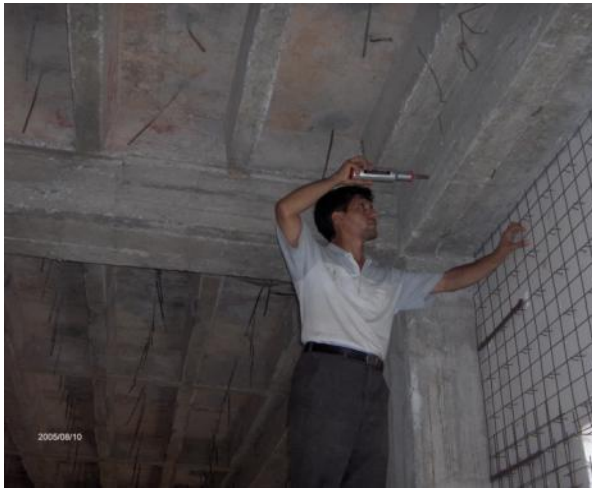
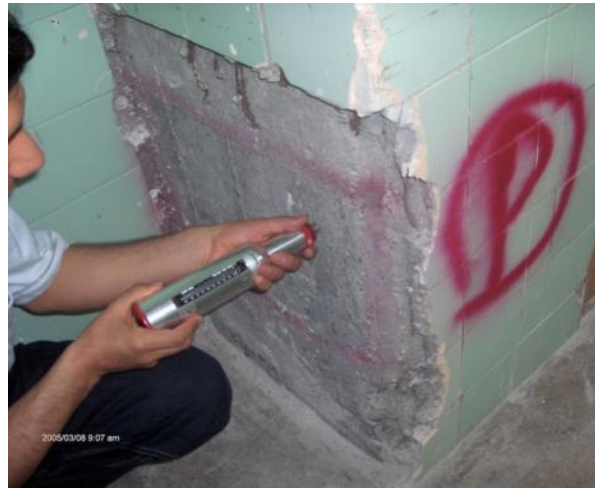
Non Destructive Tests to evaluate the existing structure. Determining concrete compressive strength by means of SCHMIDT Hammer. Bandar Abbas, Iran.08/03/2005

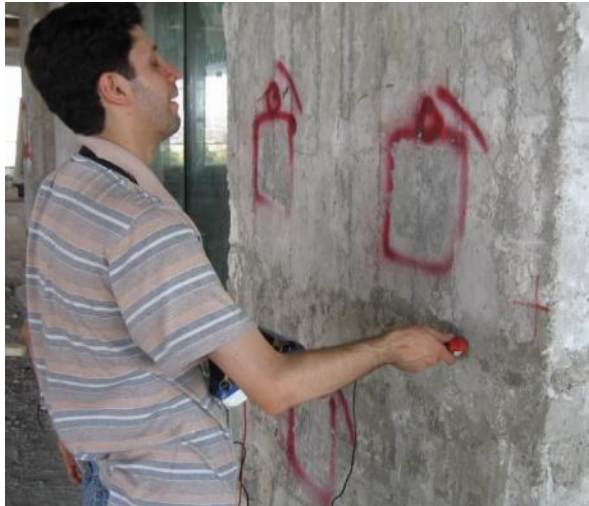
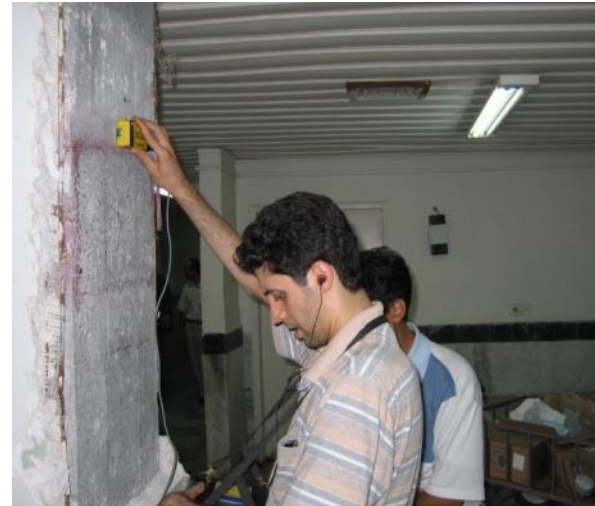
Non Destructive Tests to evaluate the existing structure. Ultrasound Wave Transducer to determine concrete consistency (left). Locating the rebars in the building structural elements by Rebar Locator (right). Bandar Abbas, Iran 06/28/05

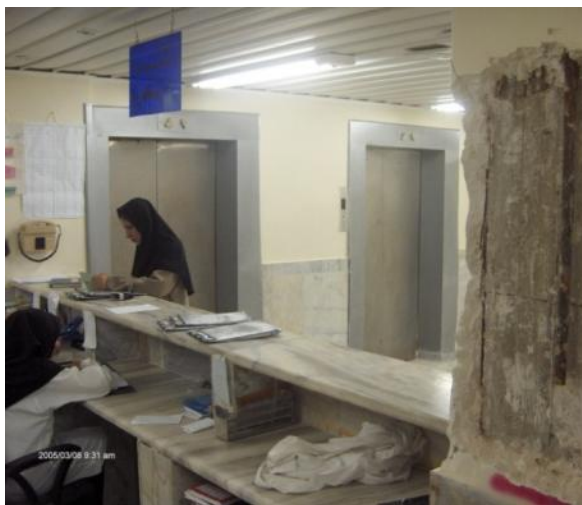
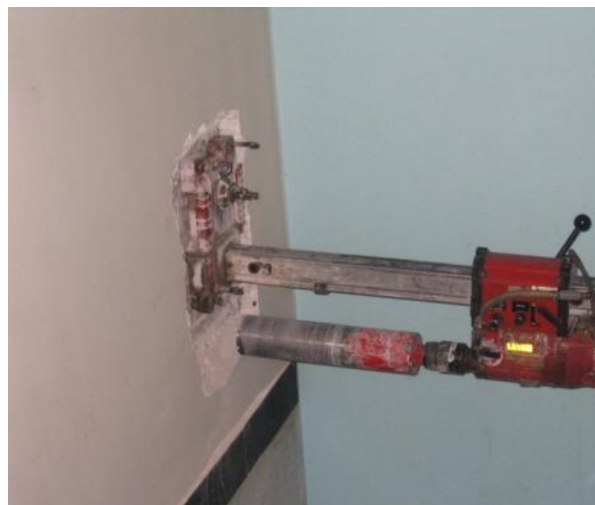
Destructive and Non Destructive Tests are done even in the running parts of the Hospital. Mohammadi Hospital, Bandar Abbas, Iran 06/20/2005

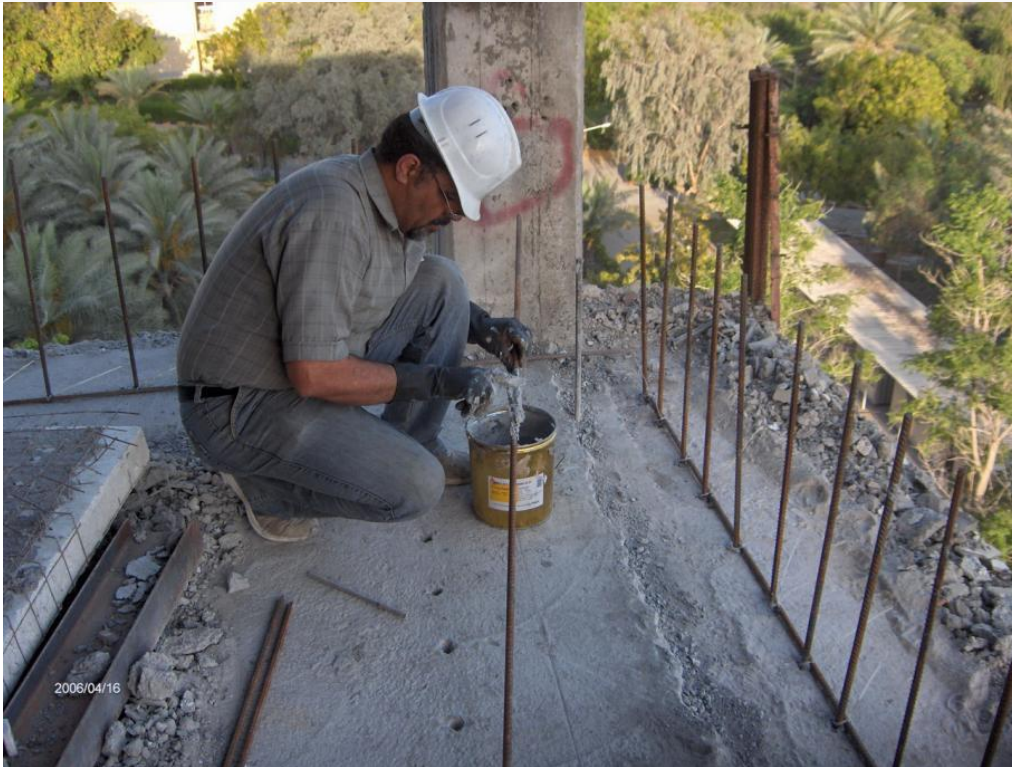
Implanting rebars in the floor decks to establish new RC concrete shear walls to resist earthquake lateral force. Mohammadi Hospital, Bandar Abbas, Iran 04/16/06

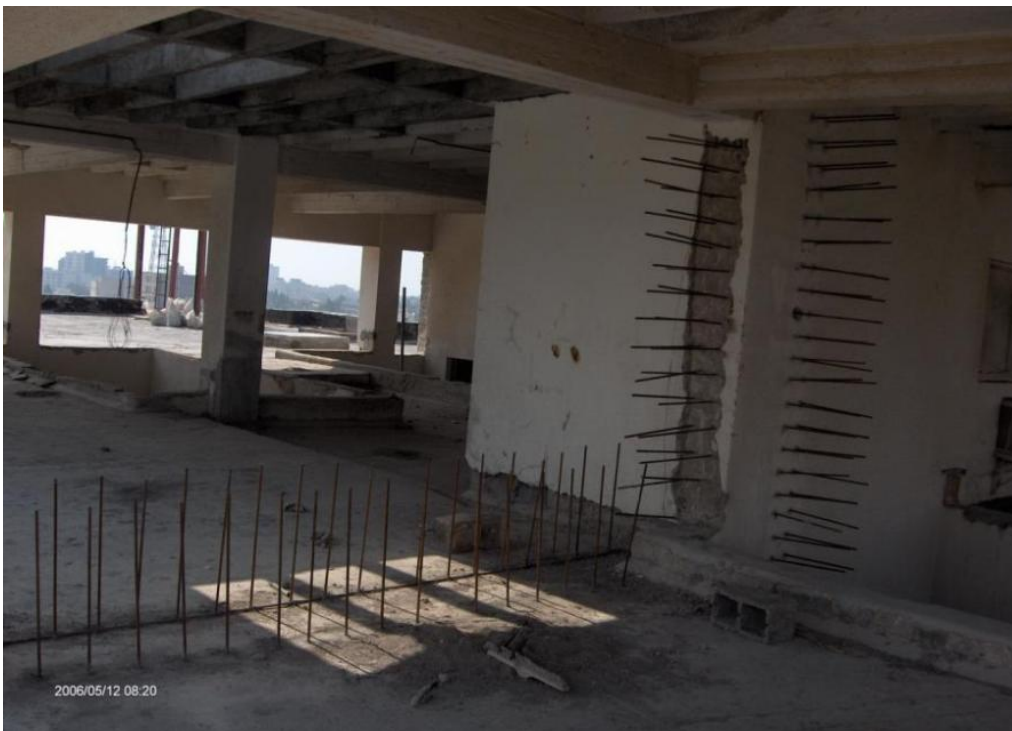
Implanting rebars in the decks and walls to establish new RC concrete shear walls to resist earthquake lateral force. Mohammadi Hospital, Bandar Abbas, Iran 04/20/06

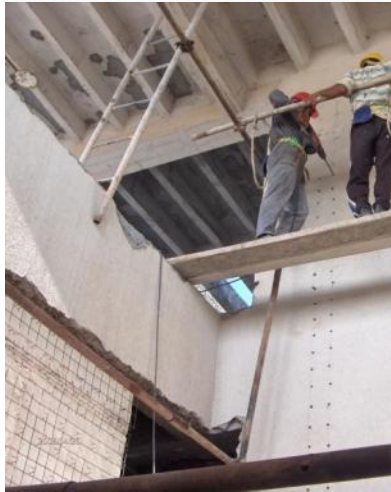
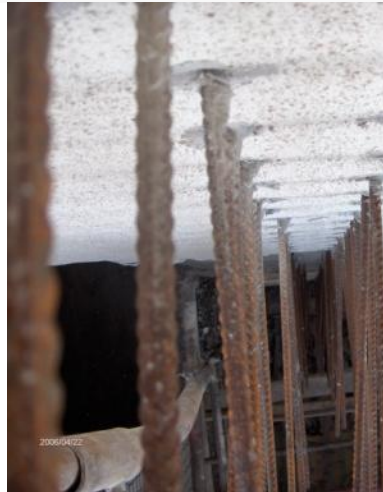
Implanting rebars in the elevator walls to establish new RC concrete shear walls to resist earthquake lateral force. Mohammadi Hospital, Bandar Abbas, Iran 04/18/06
