RADYAS
Engineered Solutions

Project: Azadi Grand Hotel Tehran, Seismic Rehabilitation Design and Supervision. Tehran, Iran 2004 – 2010

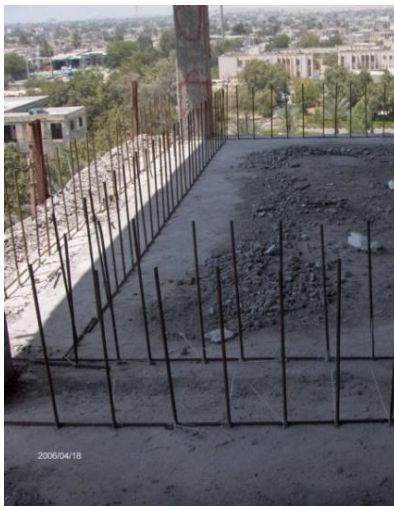
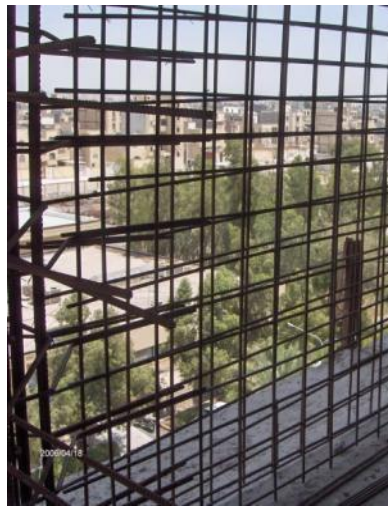
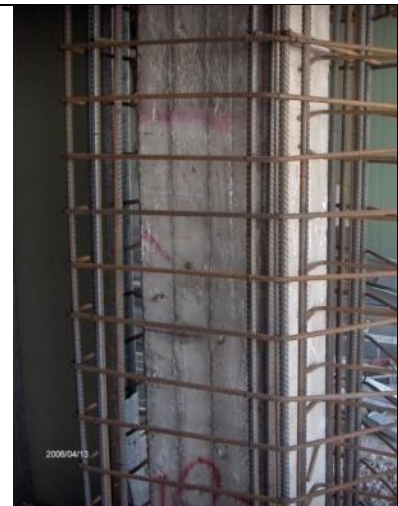
New reinforcement builds up on the implanted rebars to establish new RC concrete shear walls. Mohammadi Hospital, Bandar Abbas, Iran 04/18/2006

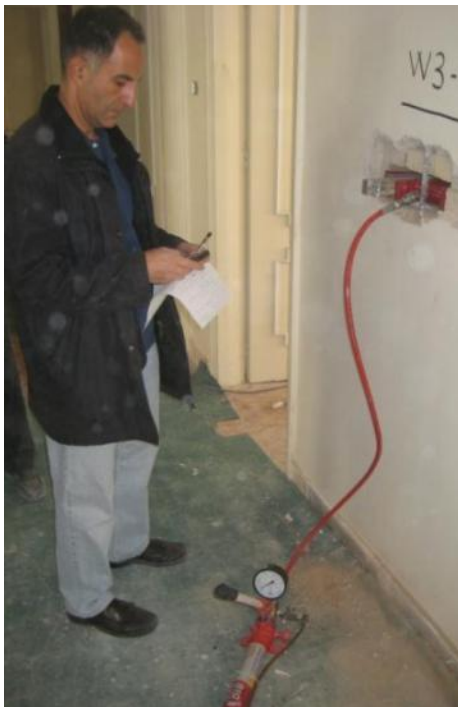
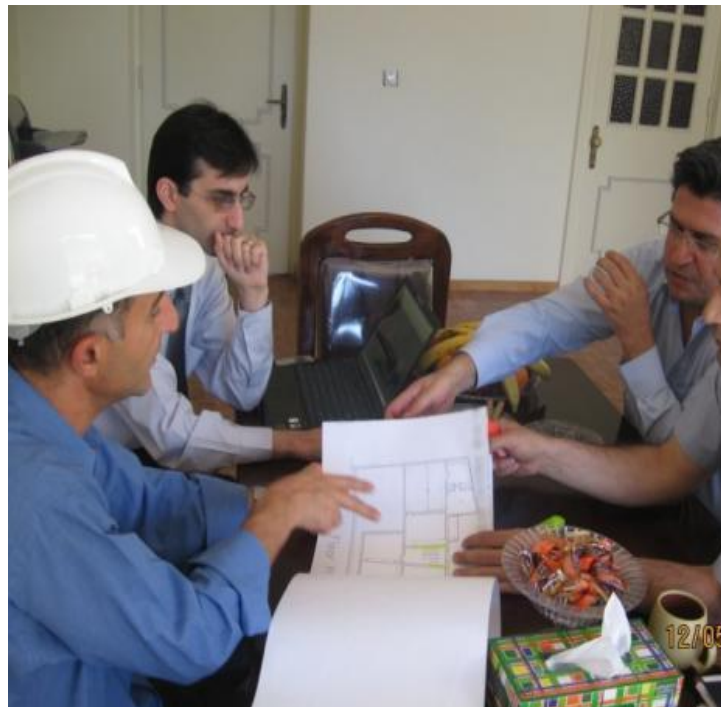
Professor Motavalli (Empa) checking the Masonry Shear Test setup (left) and discussing the structural details with Radyab Co. staff (right). Tehran, Iran 05/12/08

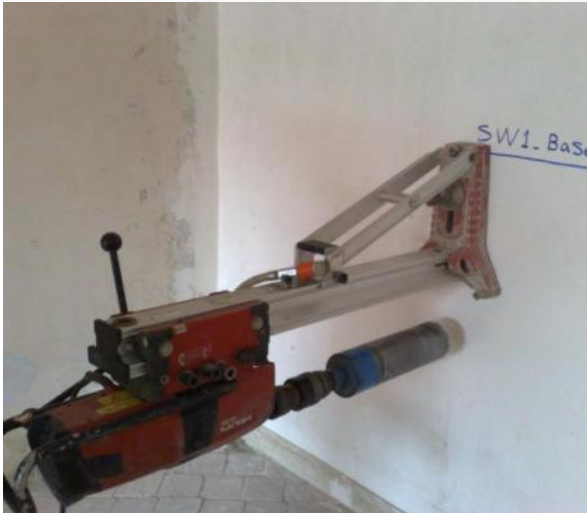
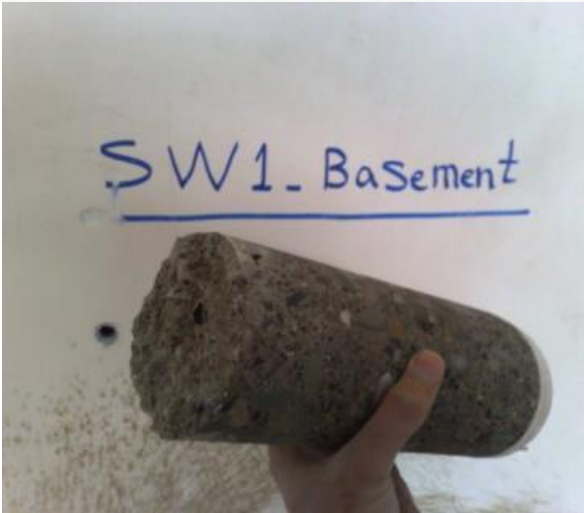
DT Tests (Concrete Core) to check the shear walls concrete quality. Tehran, 12/03/2008

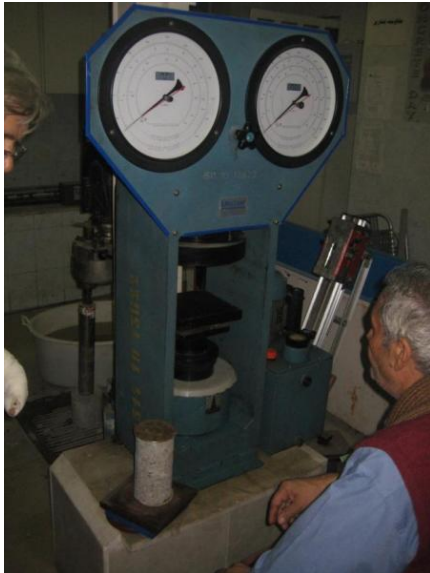
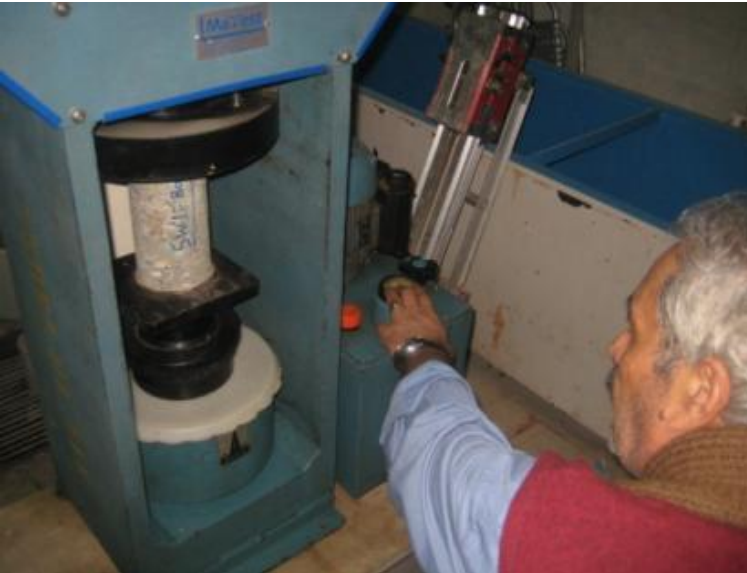
Compressive tests to check the shear walls concrete quality. Tehran, 12/24/2008

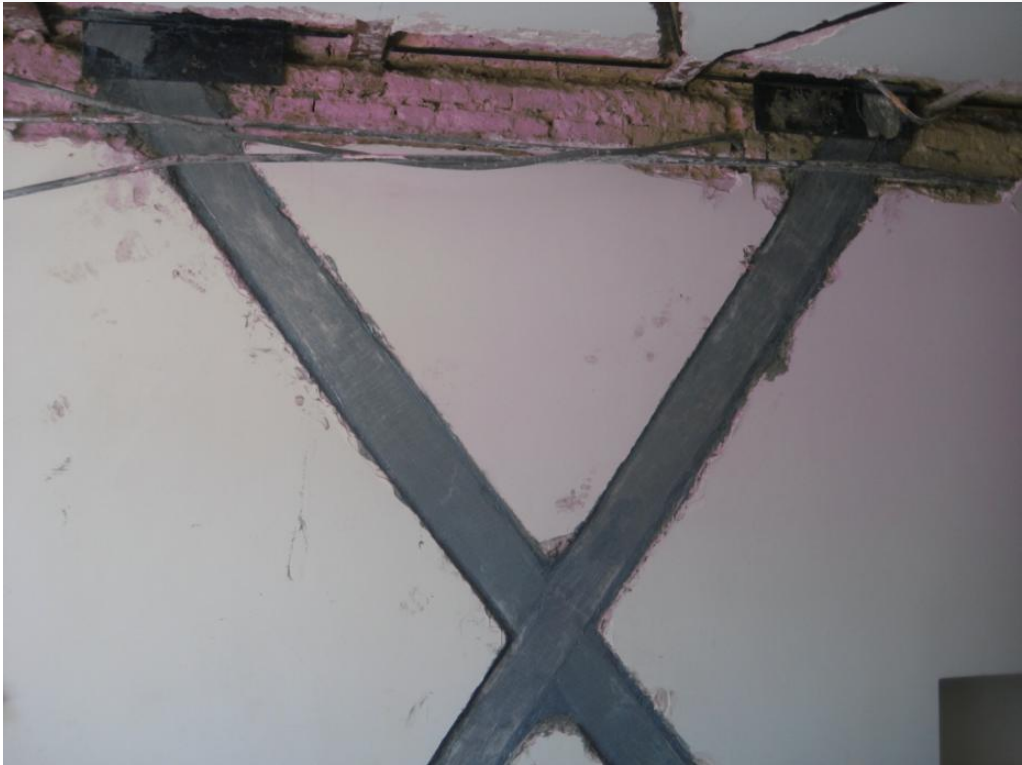
GFRP Composite Bracings to protect the masonry walls from out of plane bending. Tehran 10/19/2008

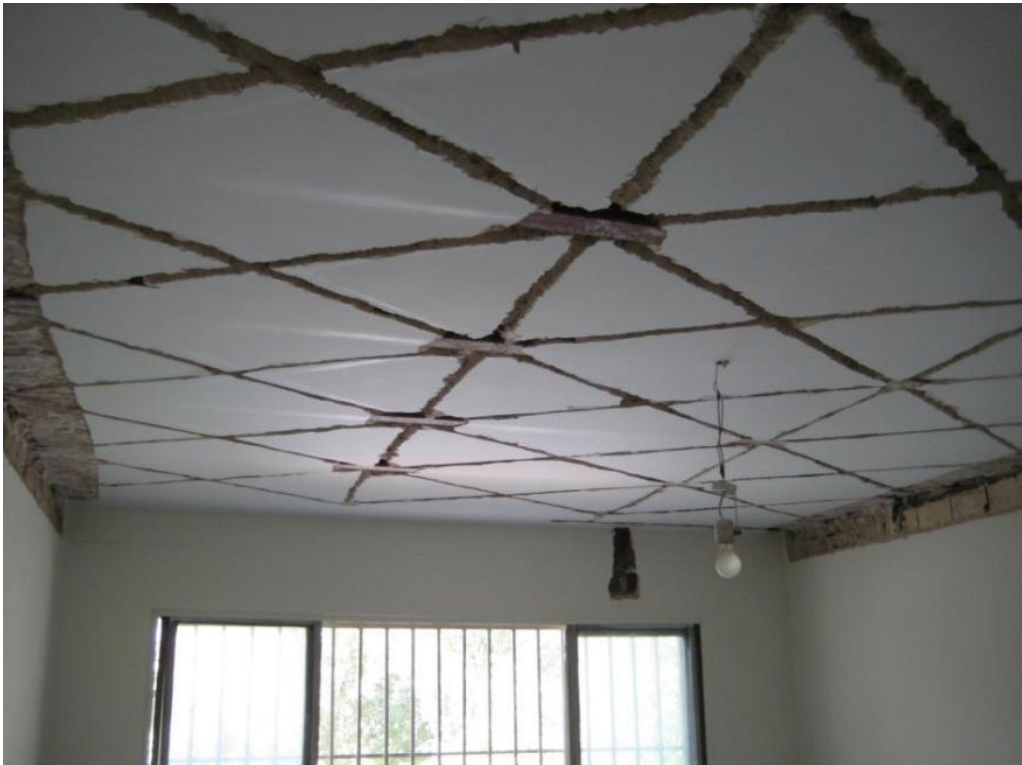
Steel Bracings provided to improve the floor deck's consistency. Tehran, Iran 06/13/2008

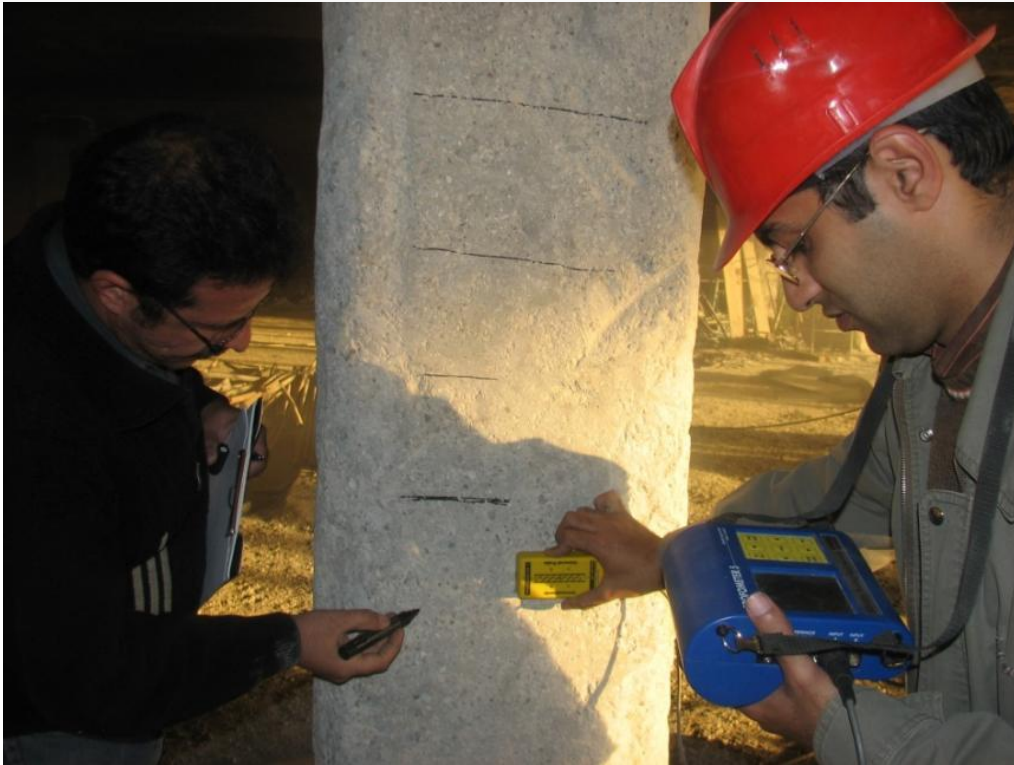
Radyab staff determining the rebars inside the RC columns by means of Rebar Locator Scanners in Structural Evaluation phase. Tehran, Iran 11/16/2007

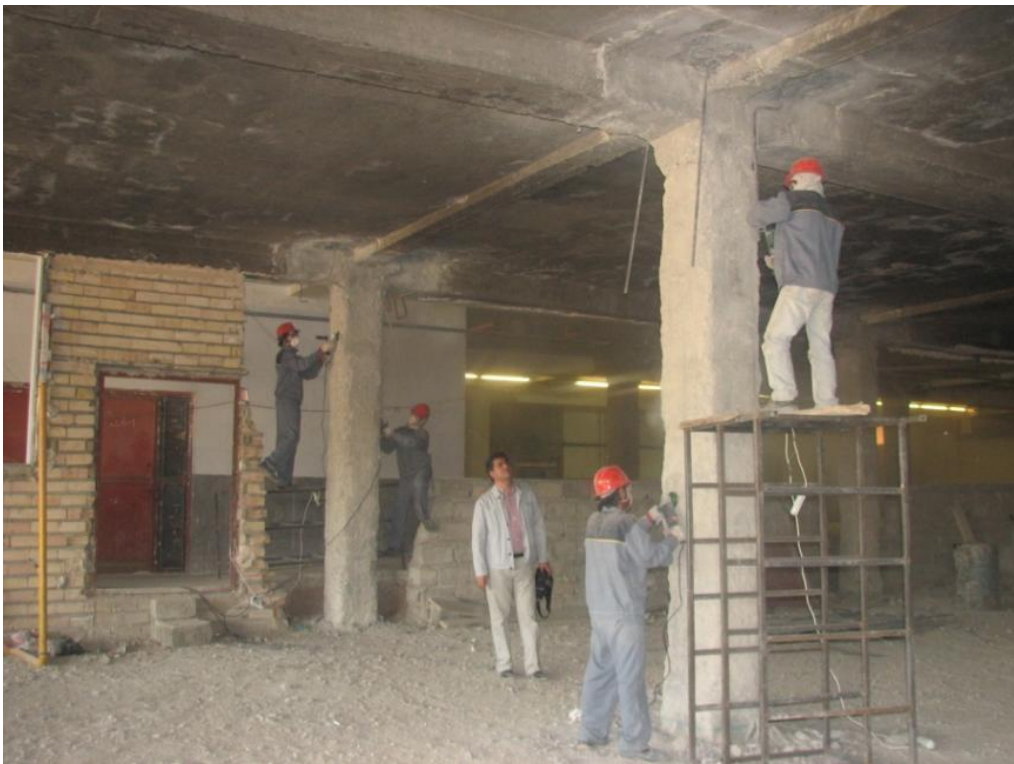
Radyab staff grinding the surface of the RC columns to prepare them for retrofitting by wrapping CFRP fabrics. Mr. Javad Najafi (middle) is supervising. Tehran, Iran 11/06/2007

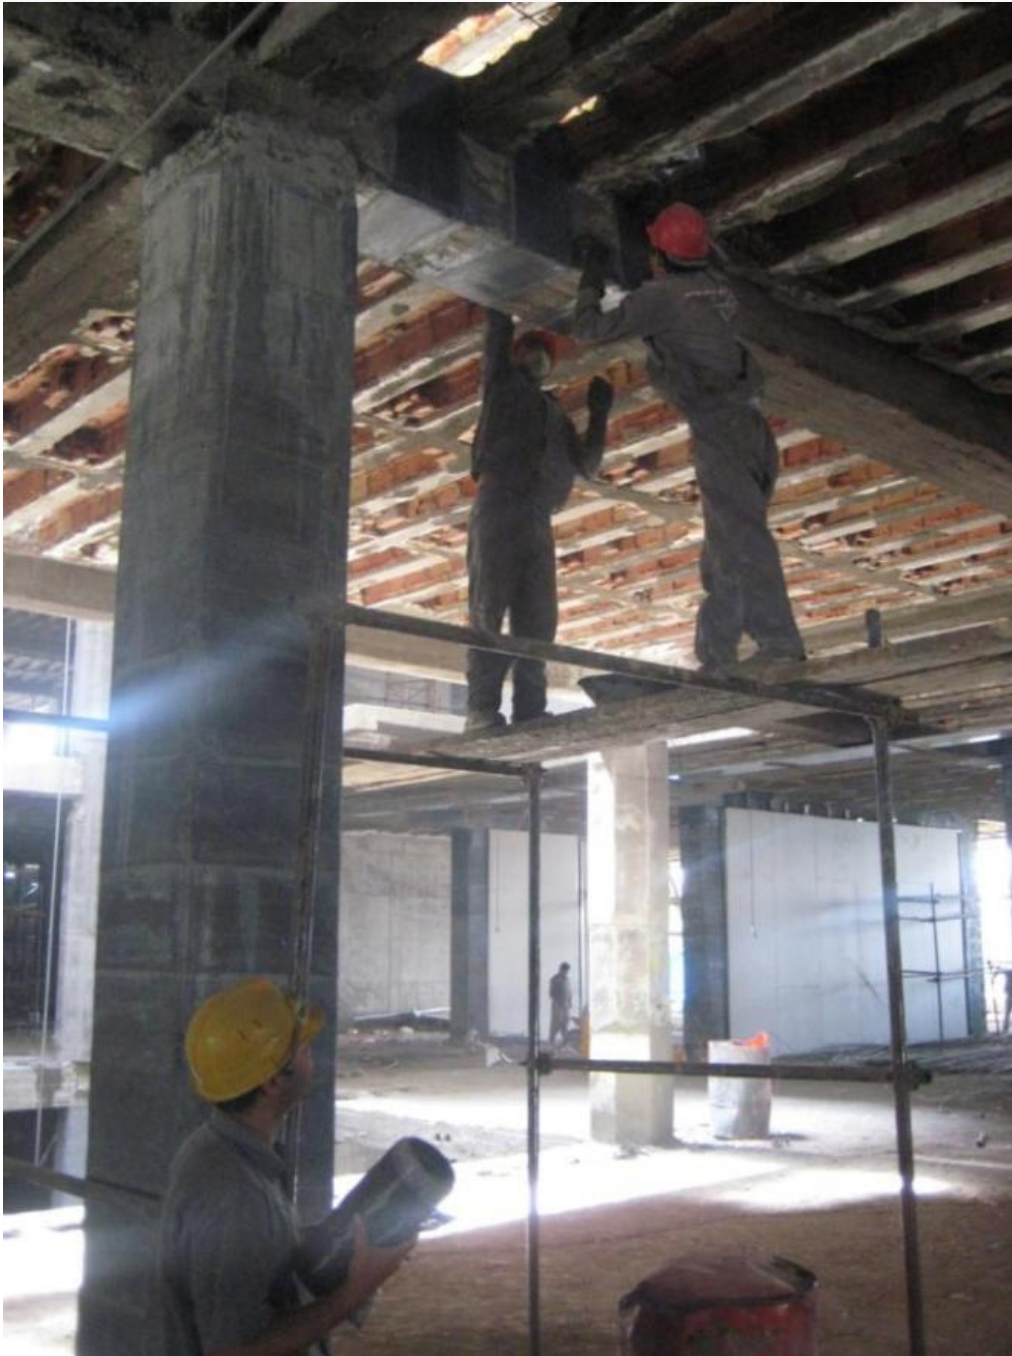
**CFRP Carbon Fiber Sheets are applied on the RC beams to upgrade their Shear Stress capacity.
Tehran, Iran 07/16/2008**

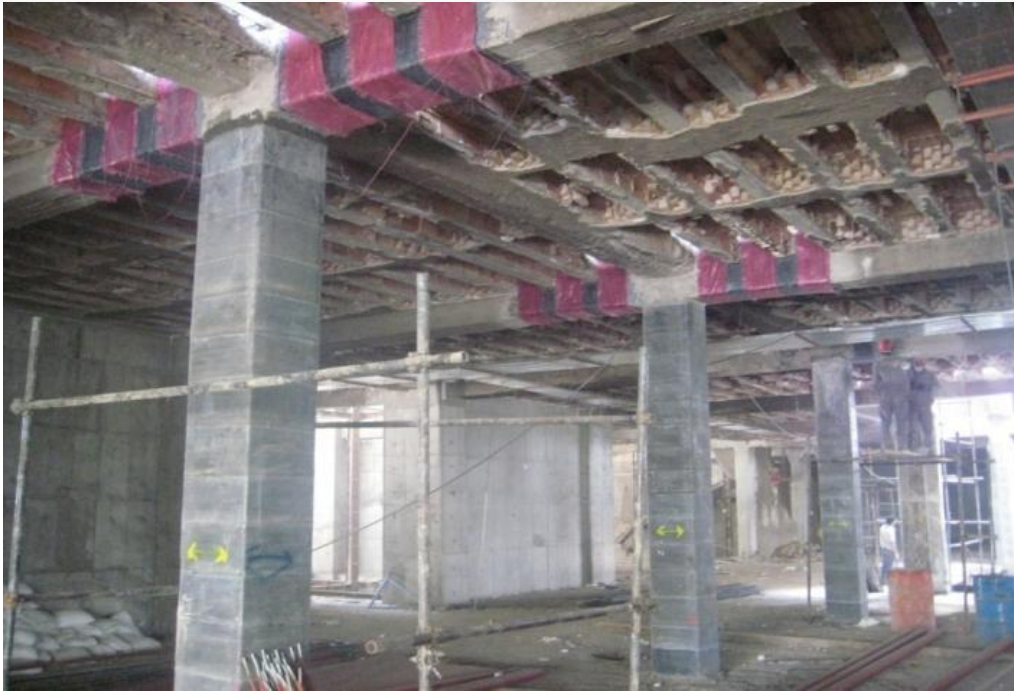
Shear strengthening of the RC beams is completed. Tehran, Iran 07/16/2008

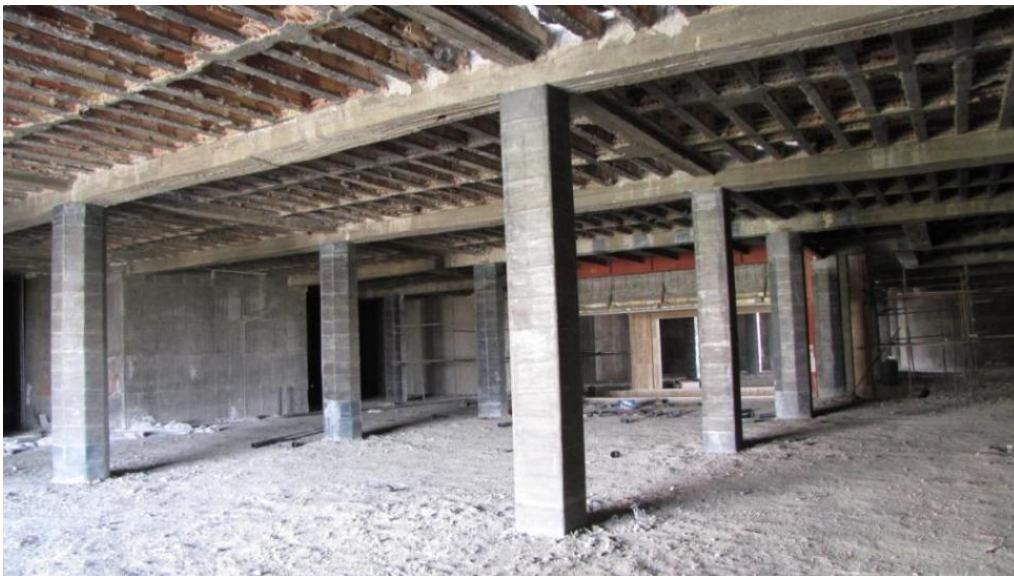
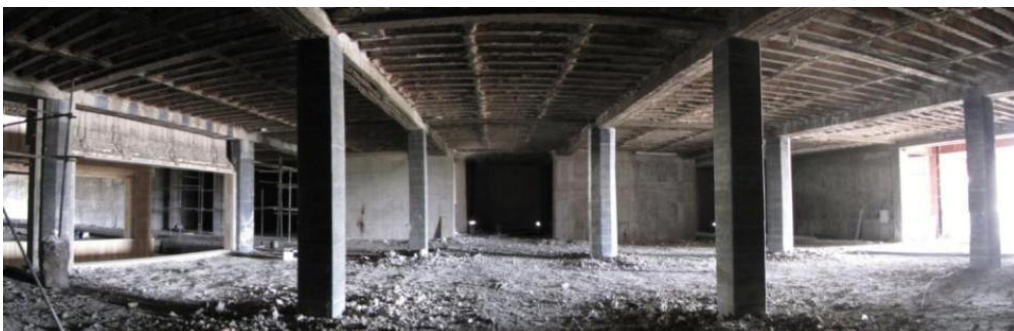
All of the old RC columns are strengthened by CFRP Carbon Fiber column wrapping method in the above pictures. Tehran, Iran 11/06/2007

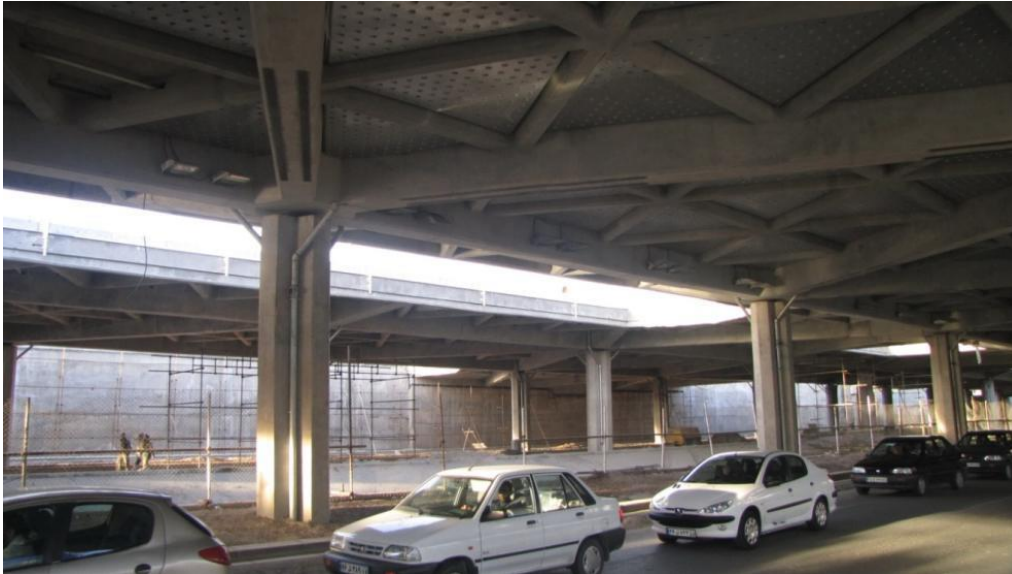
CFRP Carbon Fiber stripes are installed under the RC beams to meet the local rebar overlap demand. Qom, Iran 10/18/2009

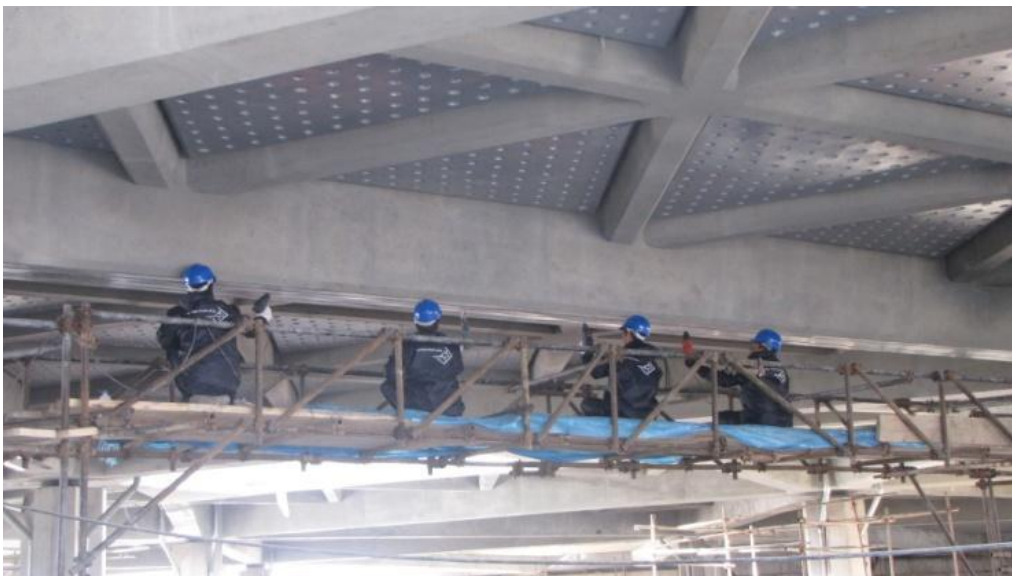
CFRP Carbon Fiber stripes are being applied under the RC beams using a high platform to allow the traffic pass underneath. Qom, Iran 01/28/2010

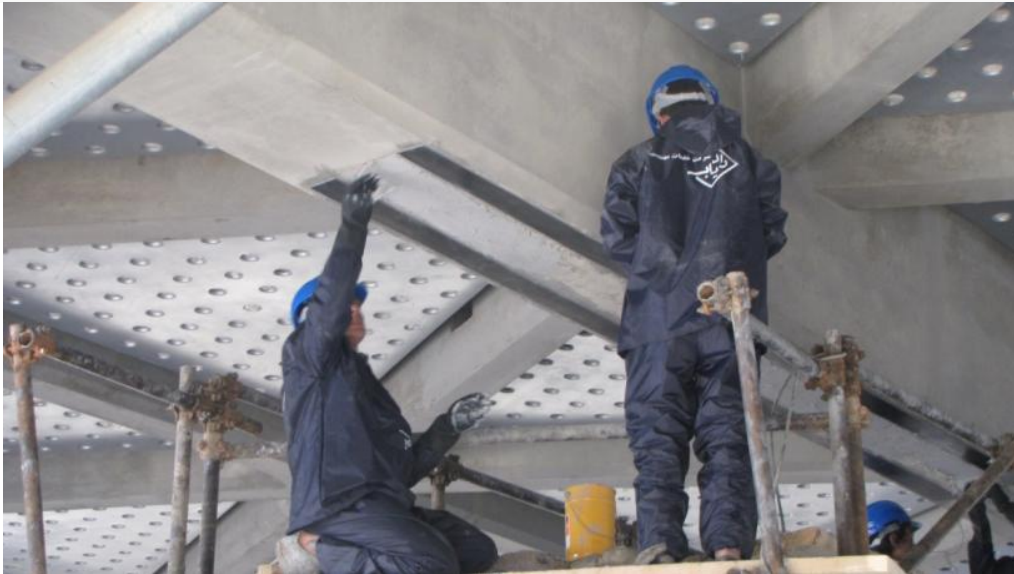
Radyab Staff is applying CFRP Carbon Fiber stripes under the RC. Qom, Iran

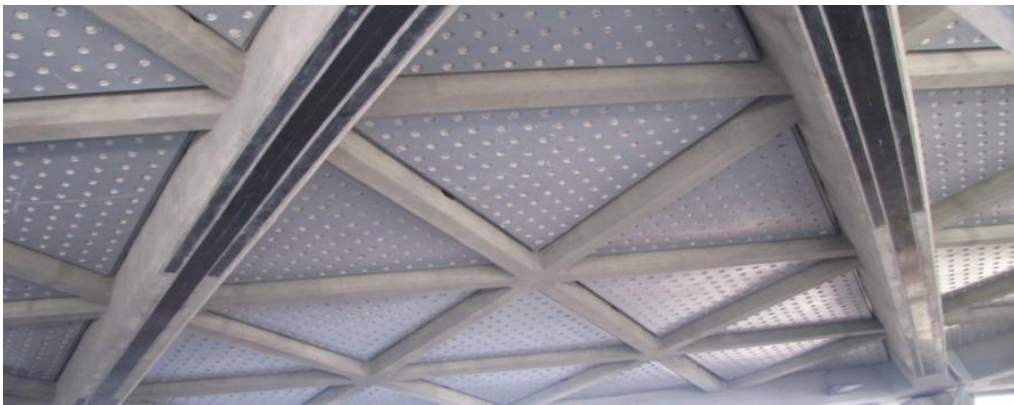
Two lateral CFRP Carbon Fiber stripes are applied under the RC beams to meet the local rebar overlap demand and the two additional stripes in the middle are to provide total consistency of the beam. Qom, Iran 01/28/2010

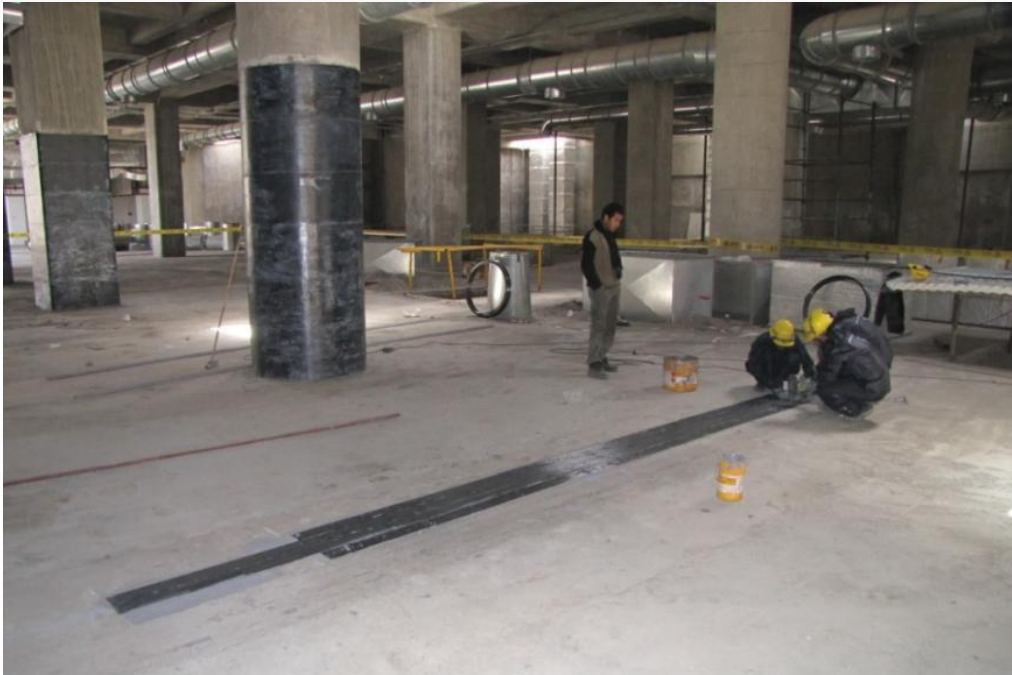
Columns and beams are being strengthened by Carbon Fiber CFRP Composites by Radyab Co., Khalij Fars shopping Mall, Shiraz, Iran 03/11/2010

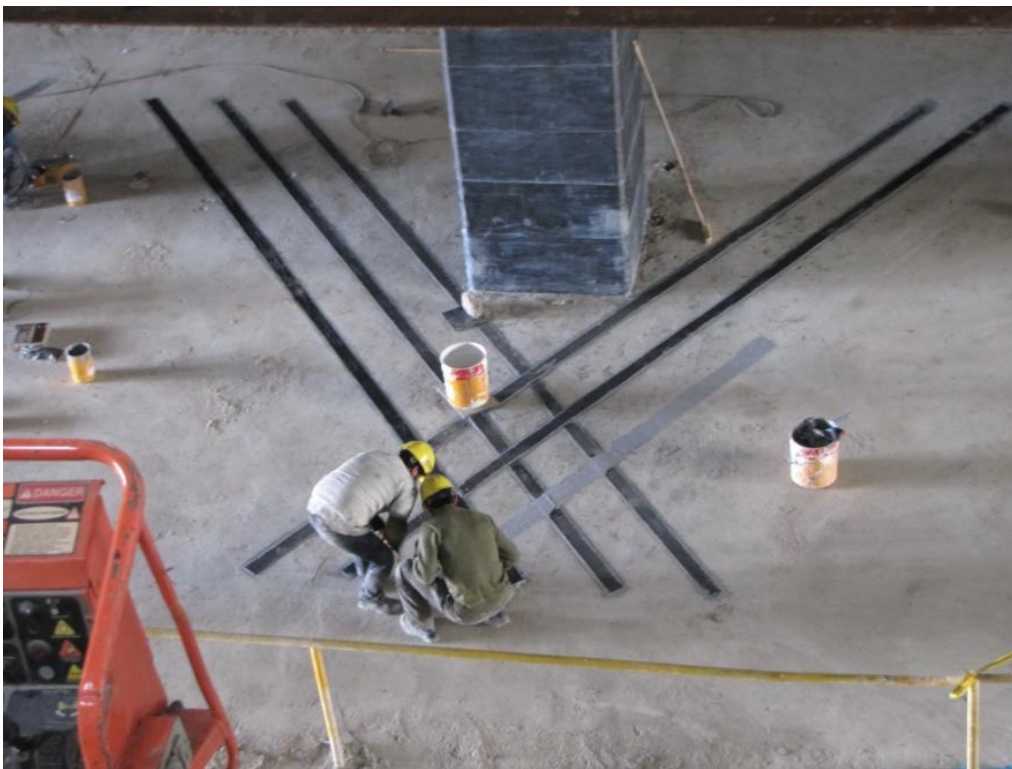
A CFRP wrapped column and diagonal CFRP stripes on the concrete deck for bending strengthening of beams. Khalij Fars shopping Mall, Shiraz, Iran 04/19/2010

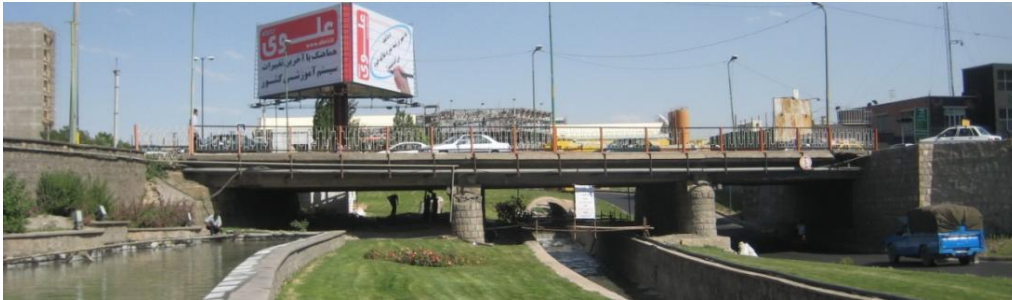
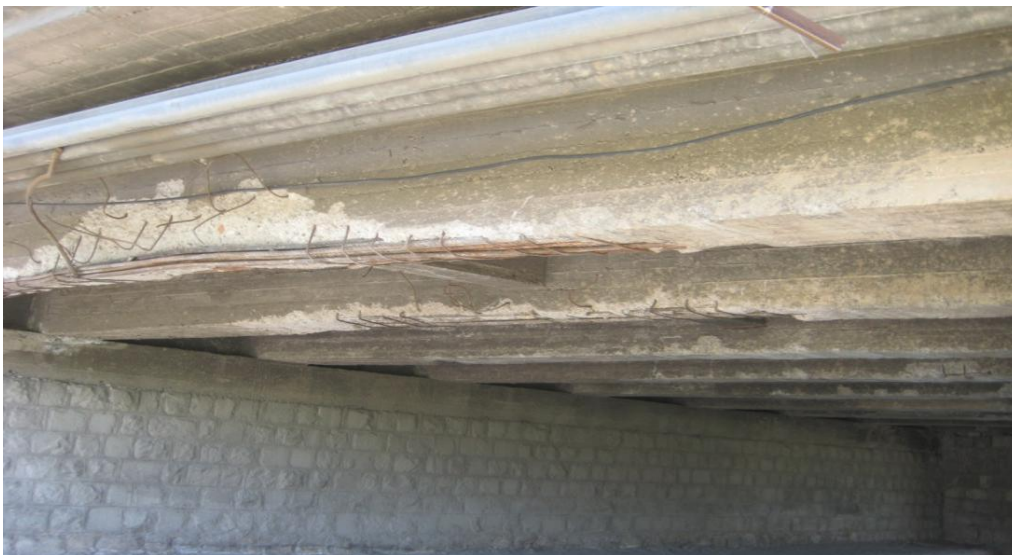
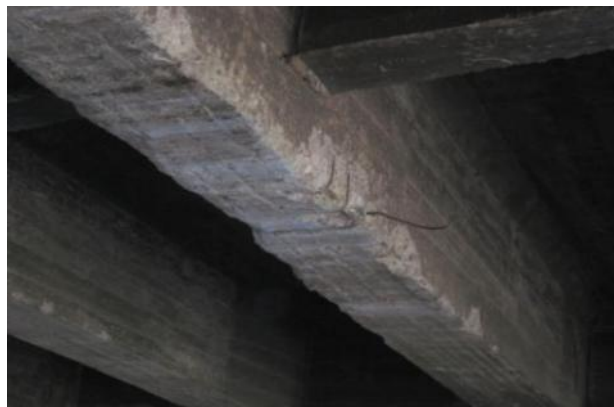
**Above and front pictures:
The RC bridge and some of
the damaged beams before
being repaired and
retrofitted**

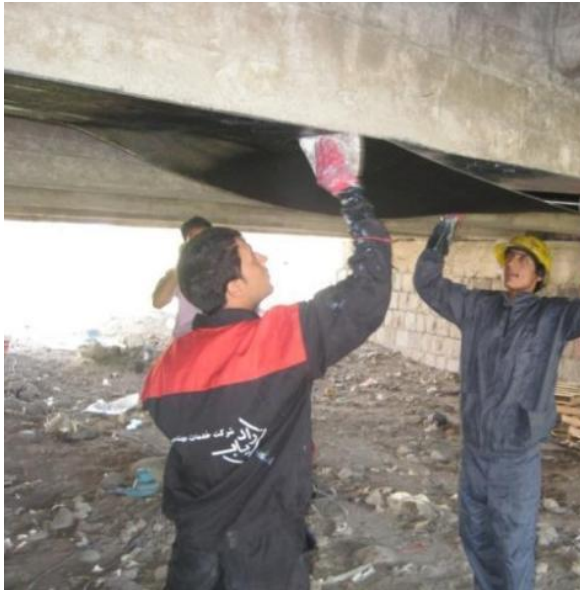
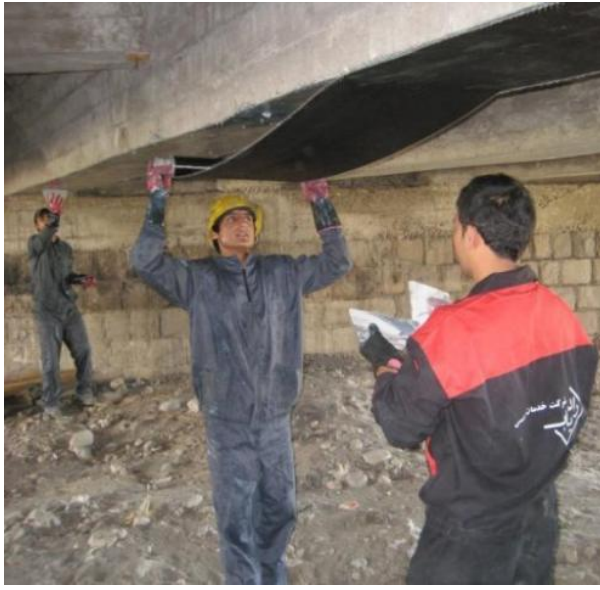
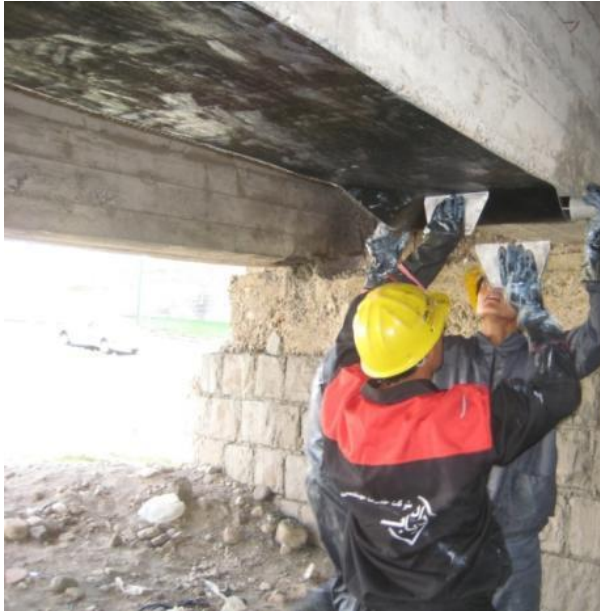
The RC damaged beams are repaired and strengthened by CFRP sheets.

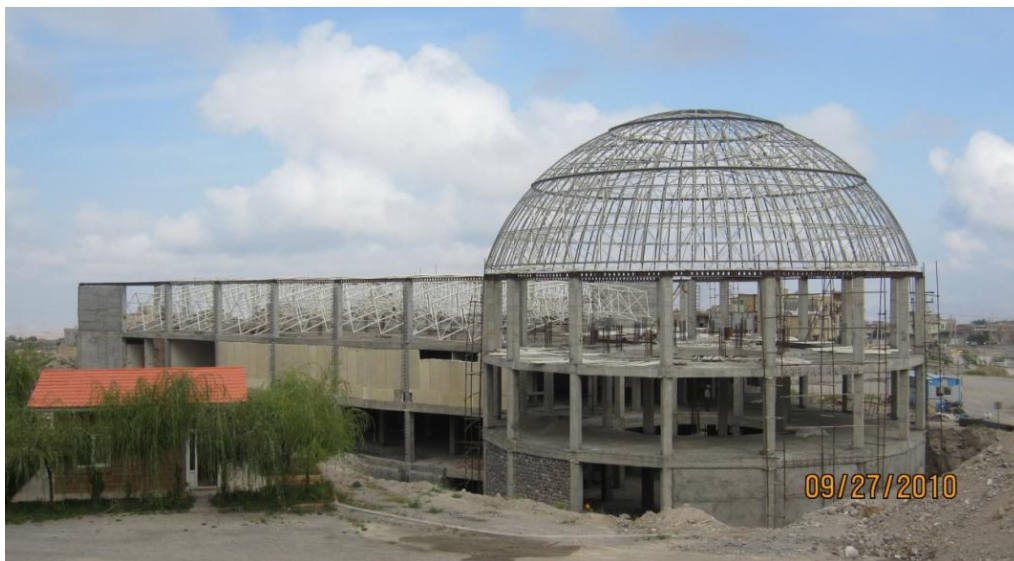
Installation of space frame in Golestan Shopping Centre, Meshkinshahr, Ardebil, Iran.

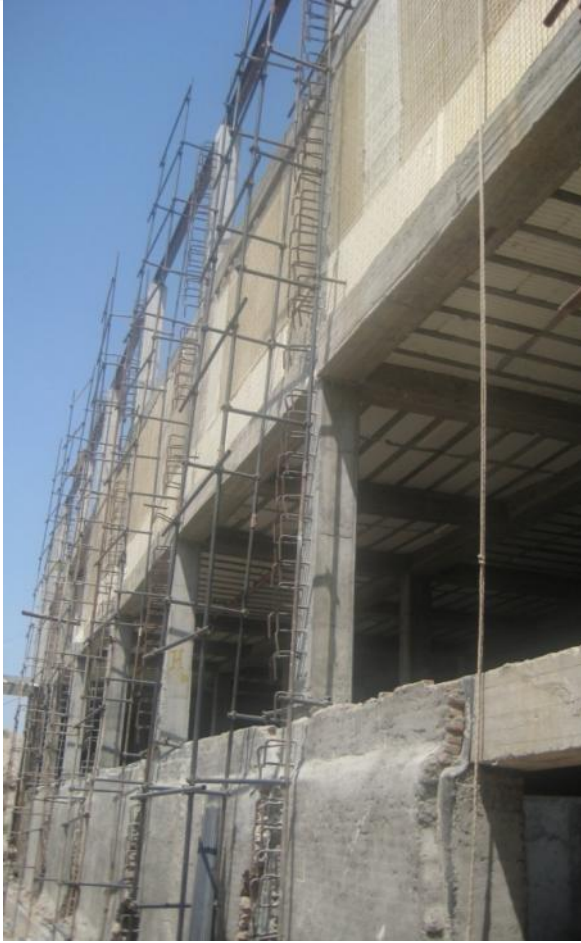
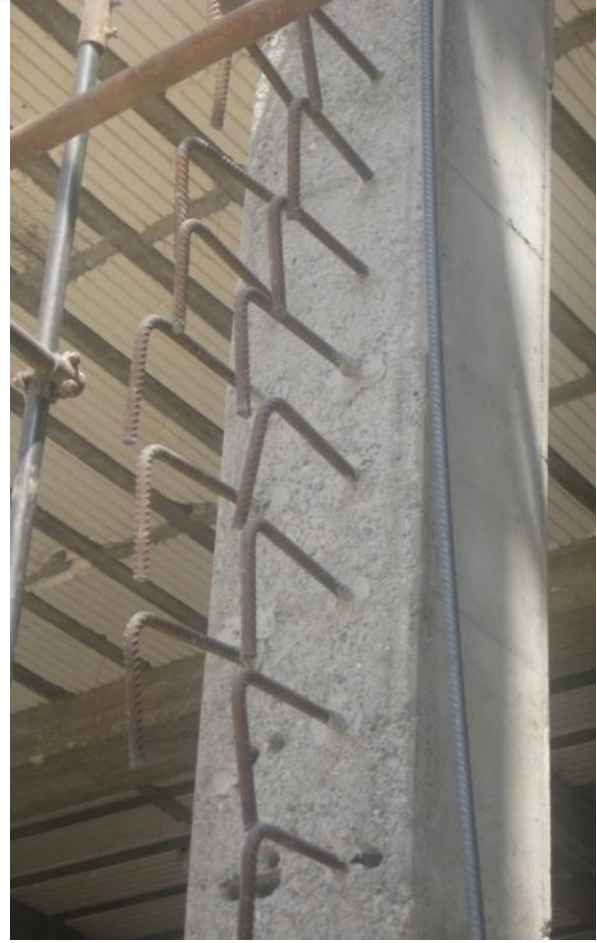
Surrounding columns bending capacity is increased by Concrete Jacketing method. Golestan shopping center. Radyab Co., Meshkinshahr, Ardebil, Iran

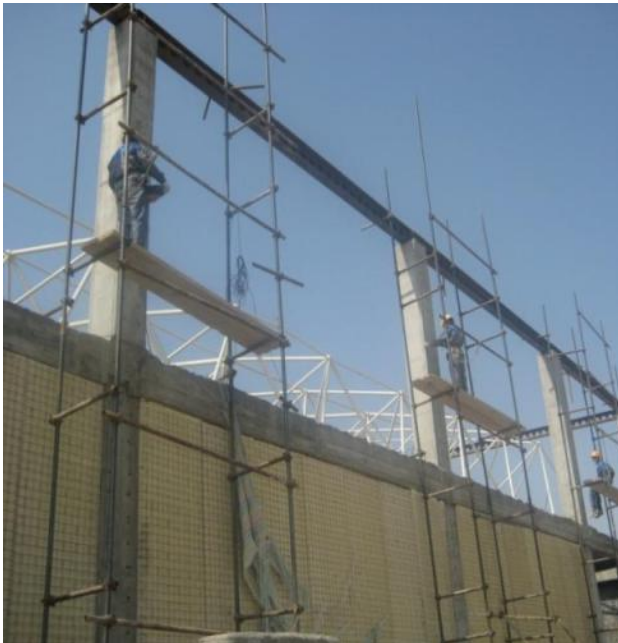
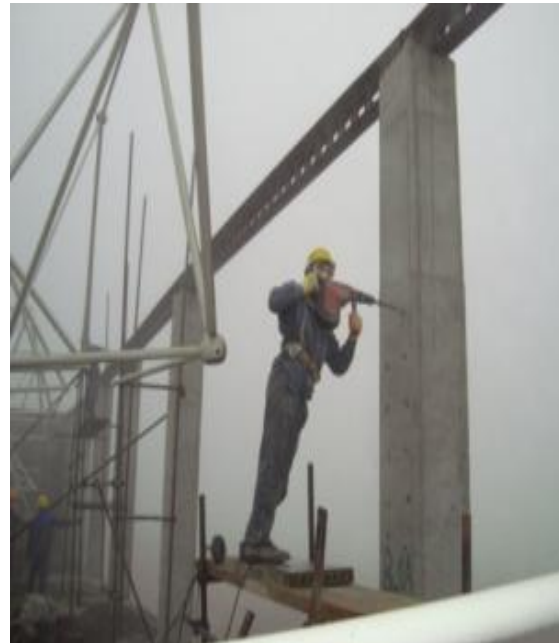
Surrounding columns are drilled based on the structural strengthening design for implanting steel bars in Concrete Jacketing method.

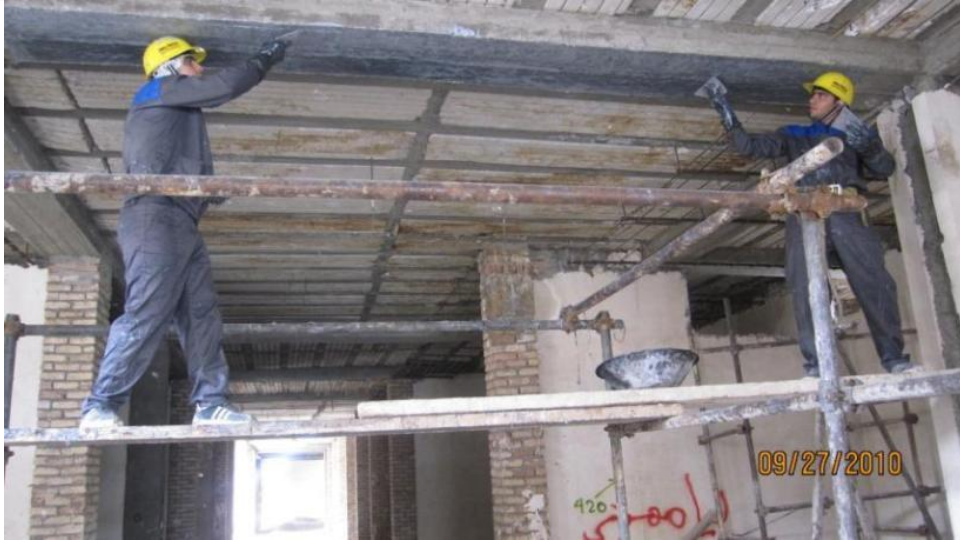
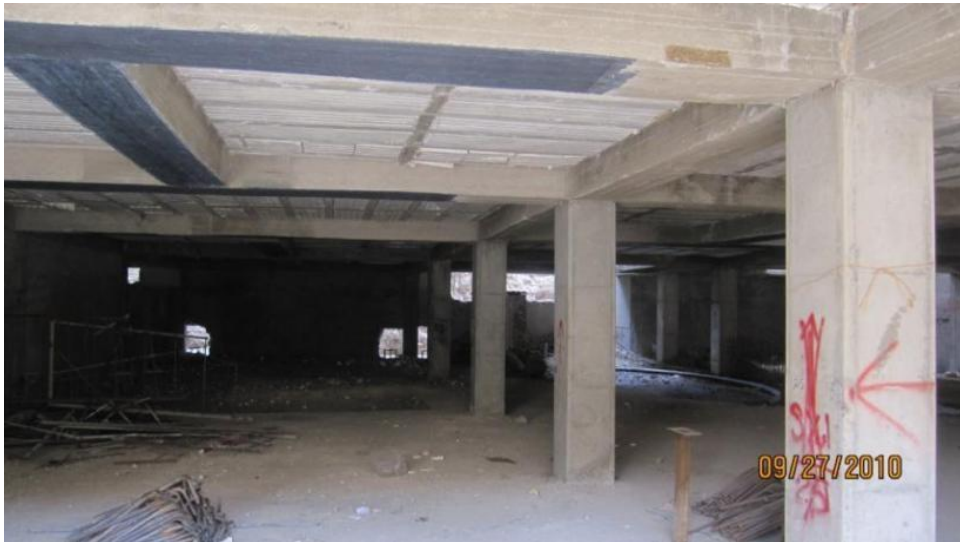
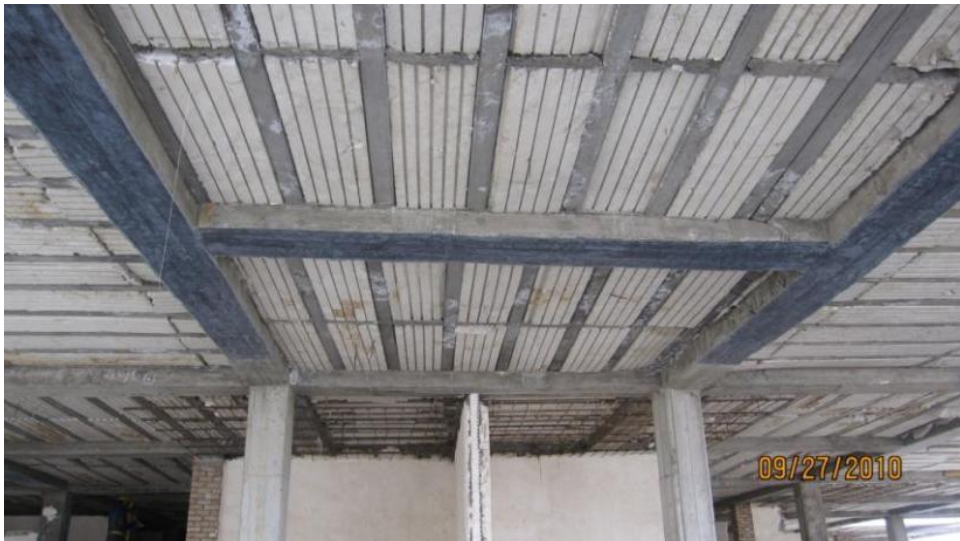
**Above Pictures: CFRP Sheets are applied beneath the beams to increase their bending capacity.
Radyab Co., Meshkinshahr, Ardebil, Iran**

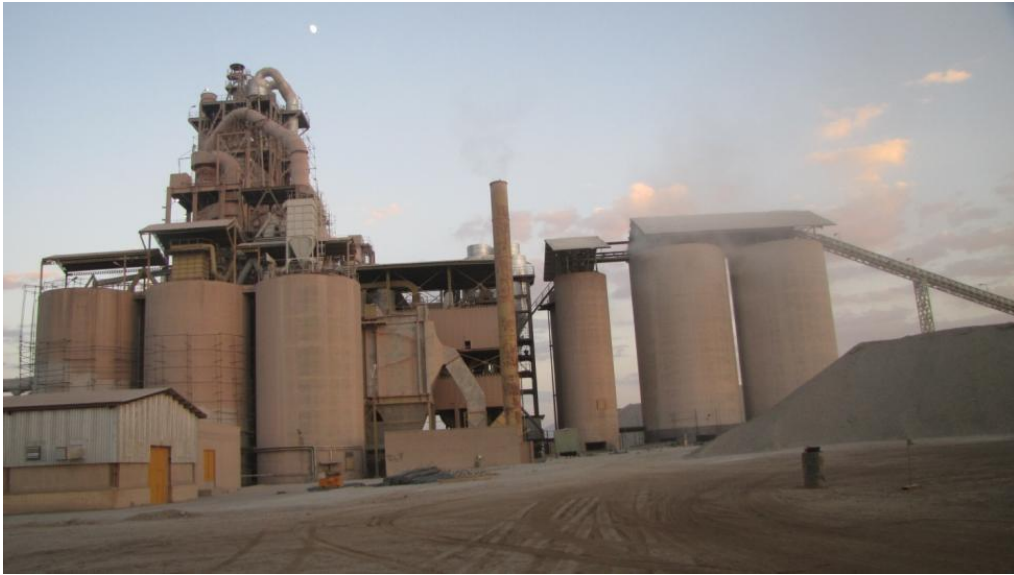
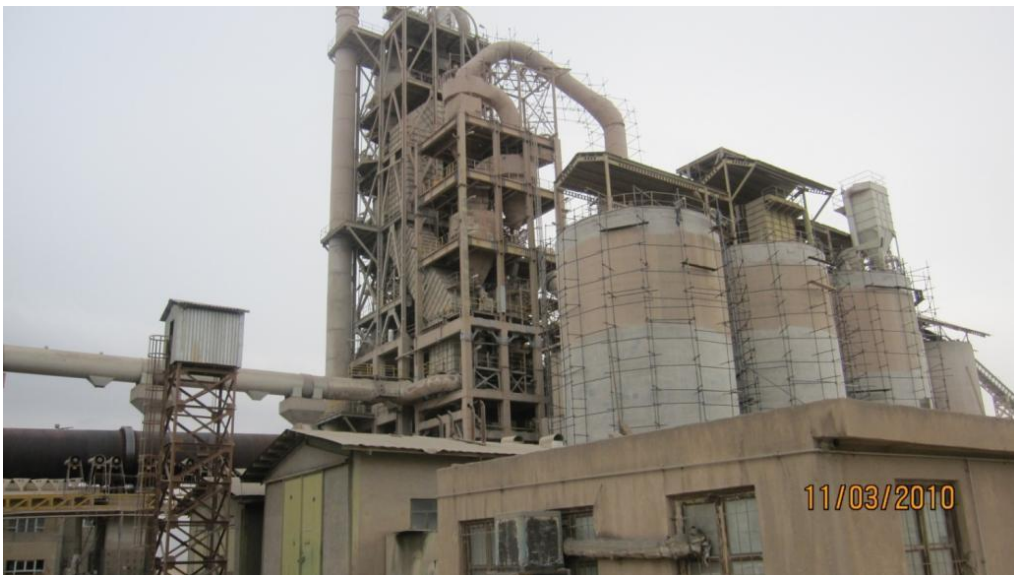
Abaadeh Cement Factory Silos, Abaadeh, Fars Province, Iran 2010 - 2011

Abaadeh Cement factory is a 35 years old RC structure. Rehabilitation was designed to upgrade the structural quality and durability of the concrete silos and the other industrial structures enabling them to work under service for more decades. CFRP sheets were externally applied to the silos in two perpendicular directions.

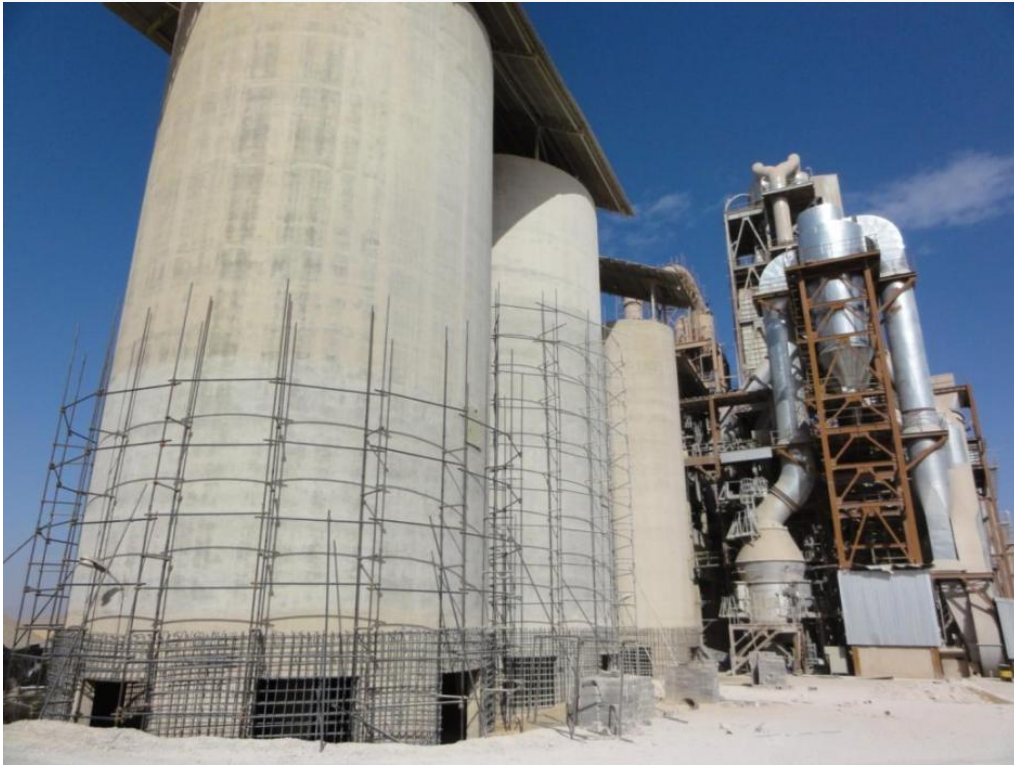
Grinding the concrete surface as the first step of structural strengthening before repairing the concrete.

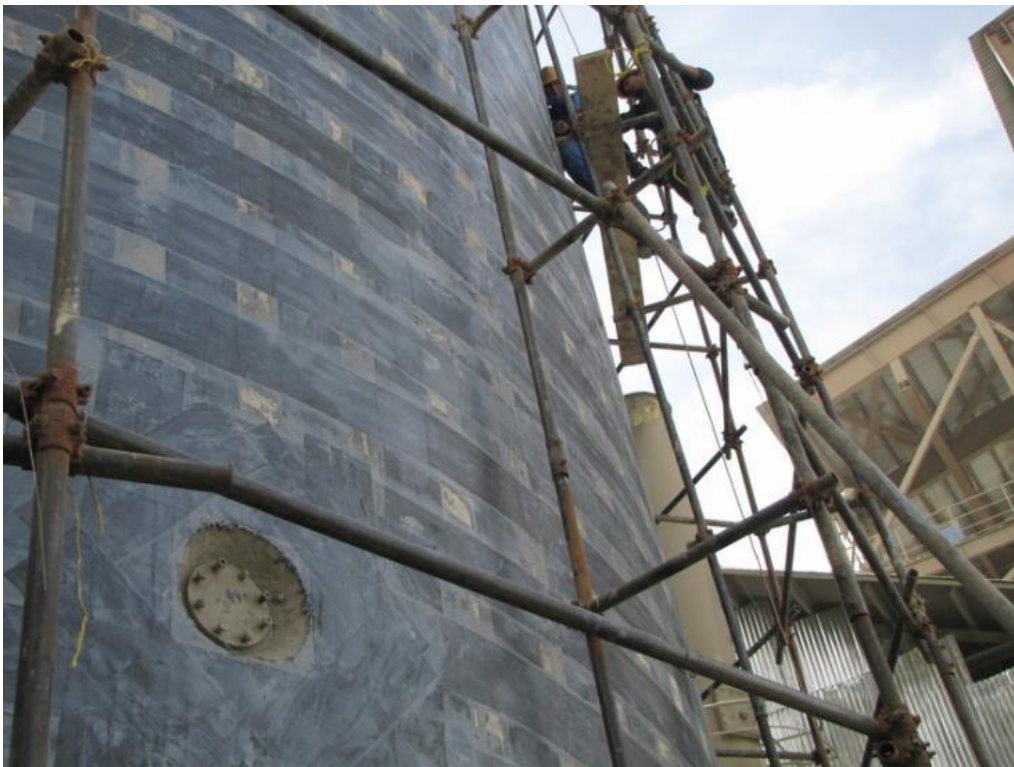
CFRP Sheets used for retrofitting the Abaadeh cement factory silos, Abaadeh, Fars Province, Iran 2010 - 2011
