RADYAS
Engineered Solutions

Project: Azadi Grand Hotel Tehran, Seismic Rehabilitation Design and Supervision. Tehran, Iran 2004 – 2010

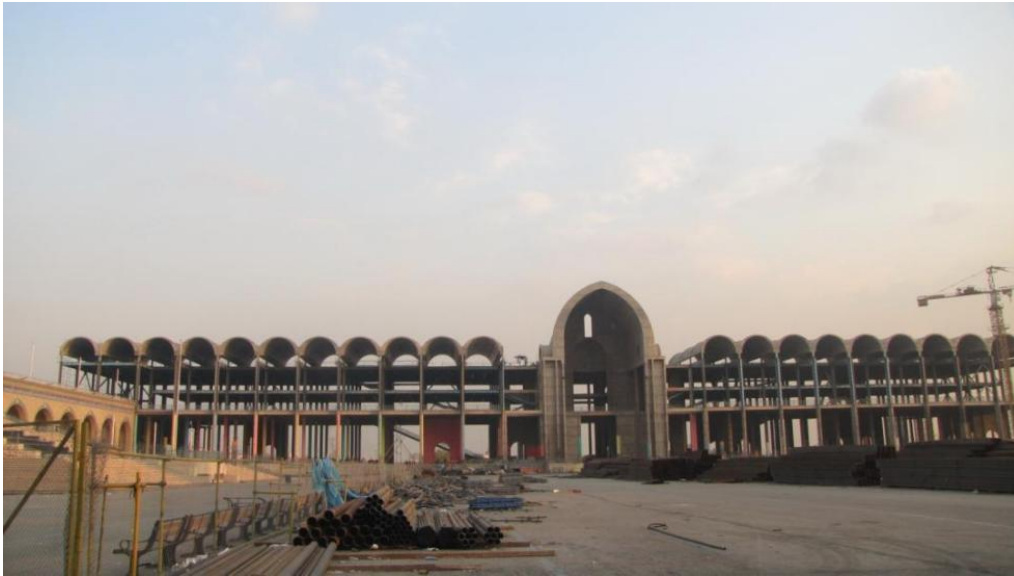
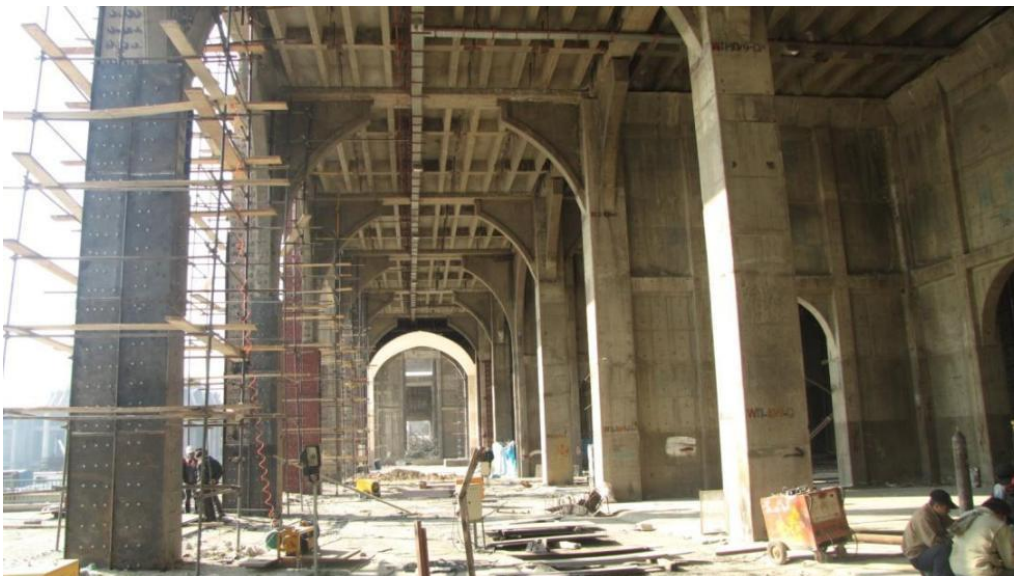
Above Pictures: Exterior and Interior view of the RC columns to be strengthened.

Tehran Mosalla (Praying place) has been under construction during last 25 years. Now, it is to be strengthened due to changes in seismic codes during that period. Design is done by University of Tehran, Faculty of Civil Engineering. Structural retrofitting design used in this project is mainly Steel Jacketing method for columns.

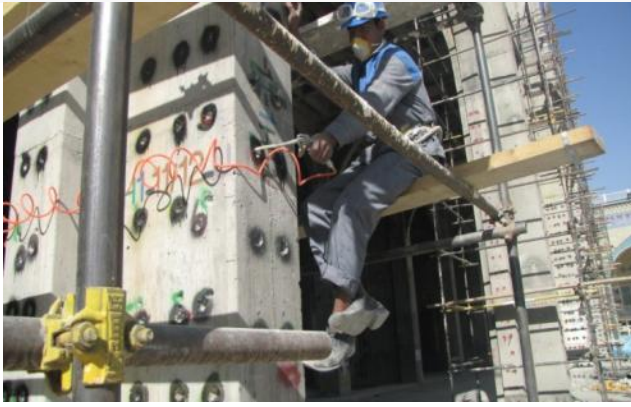
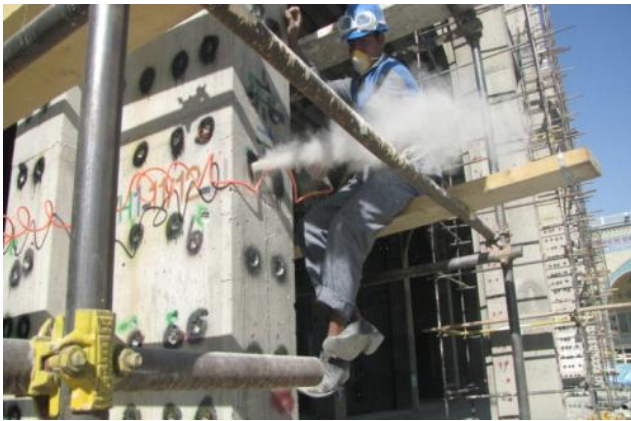
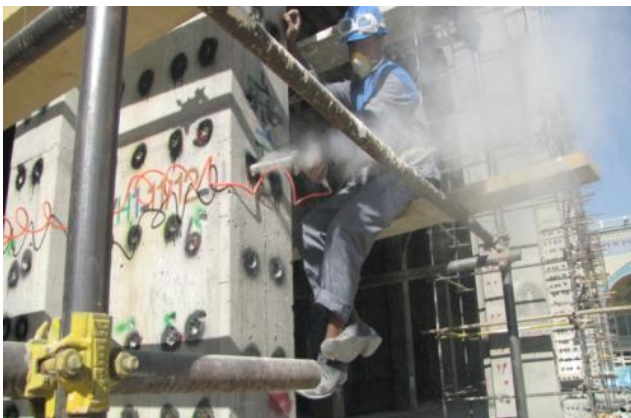
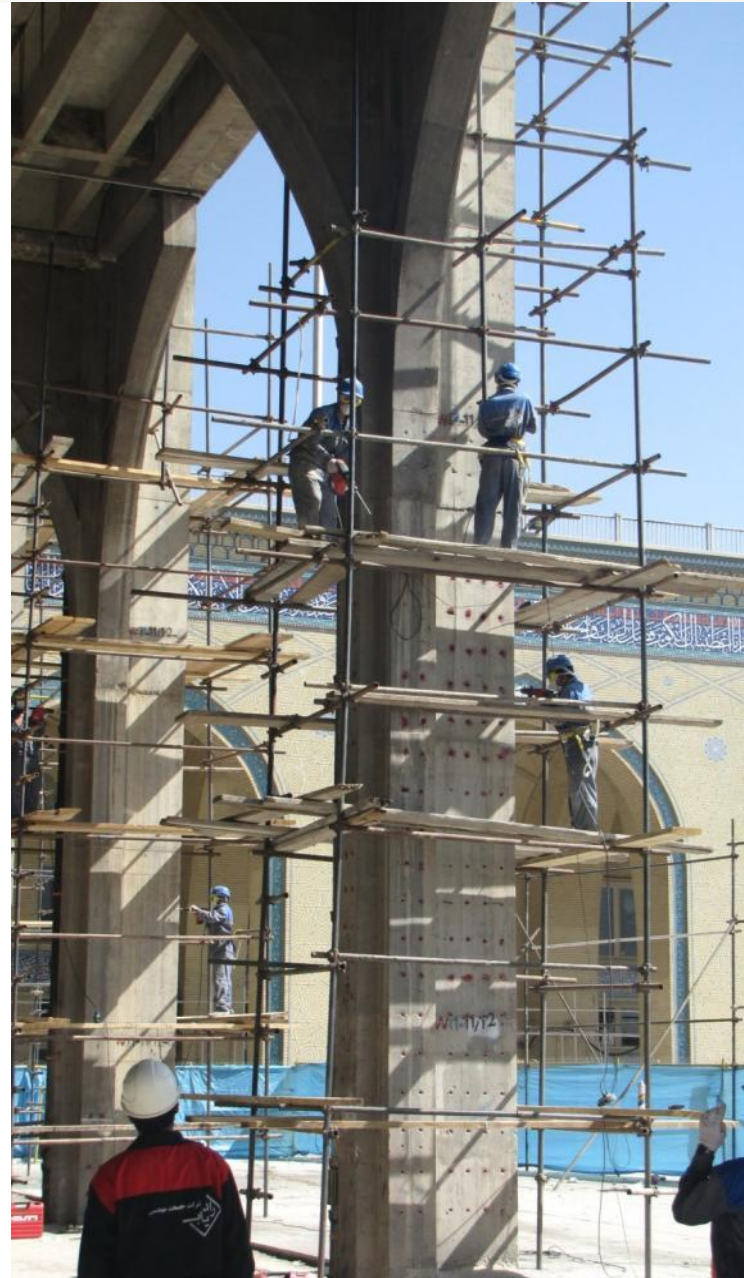
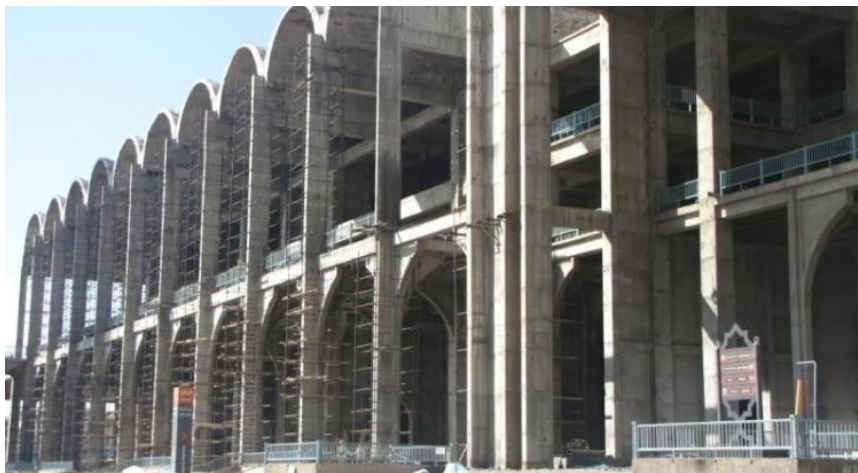
Above Pictures: Steel Jacketing starts with drilling holes to implant steel bolts inside them by means of special high strength Epoxy Resins.

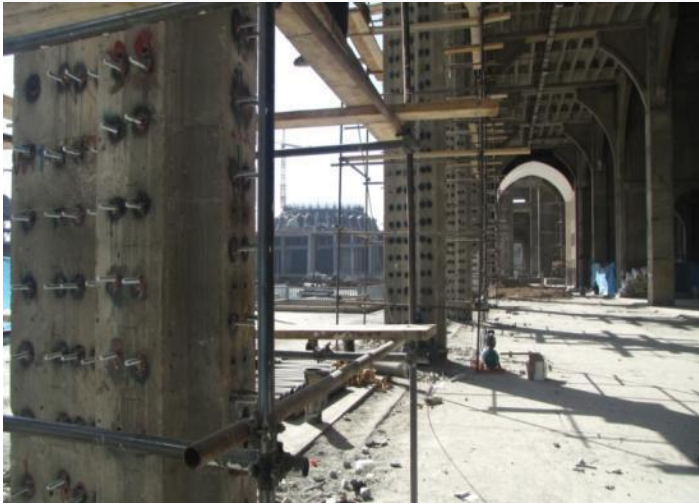
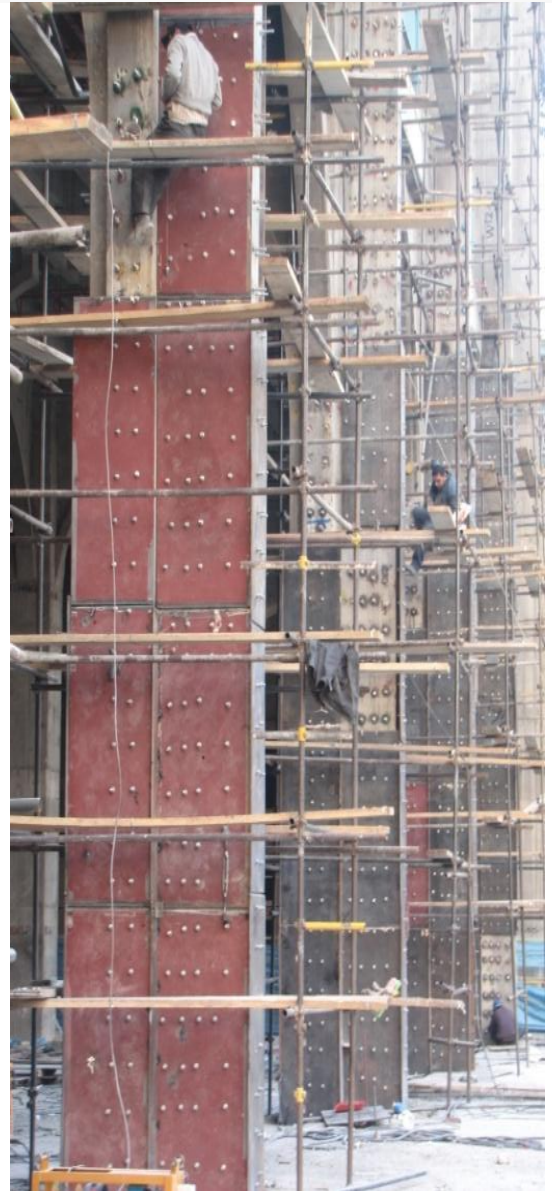
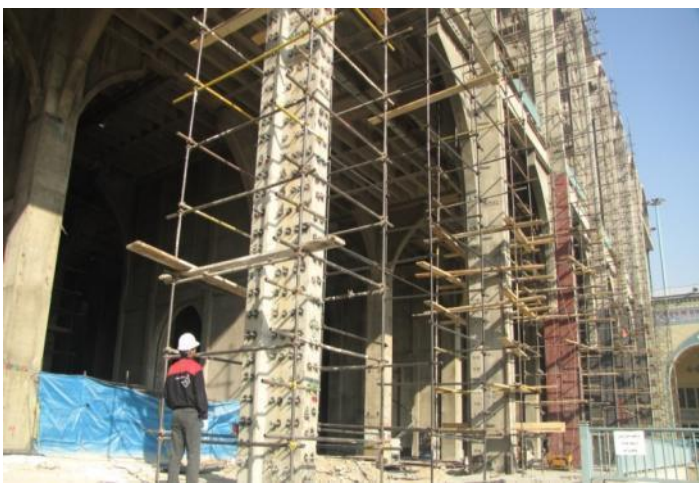
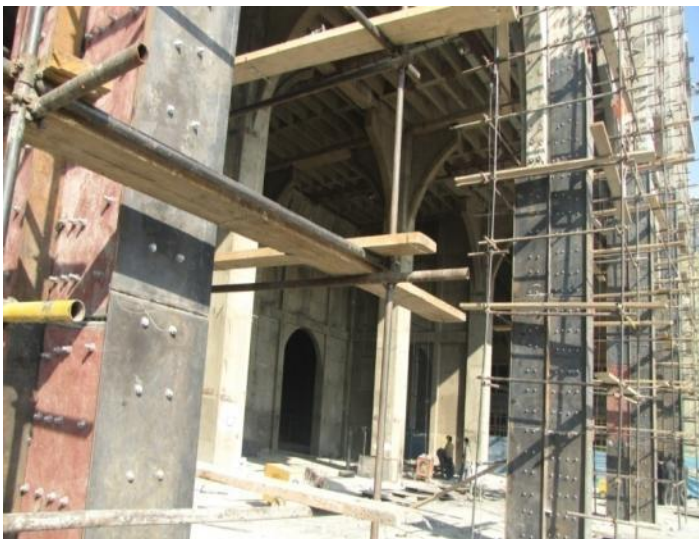
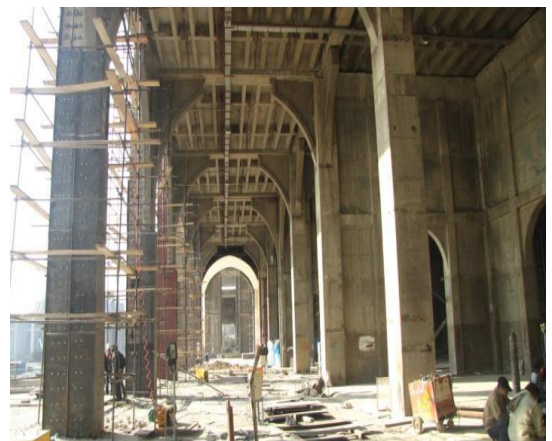
Above Pictures: Implanting steel bolts by means of special high strength Epoxy Resins and then installing the steel sheets are the next steps in this method. Grout injection is the last step to be done after completion of steel sheets welded.

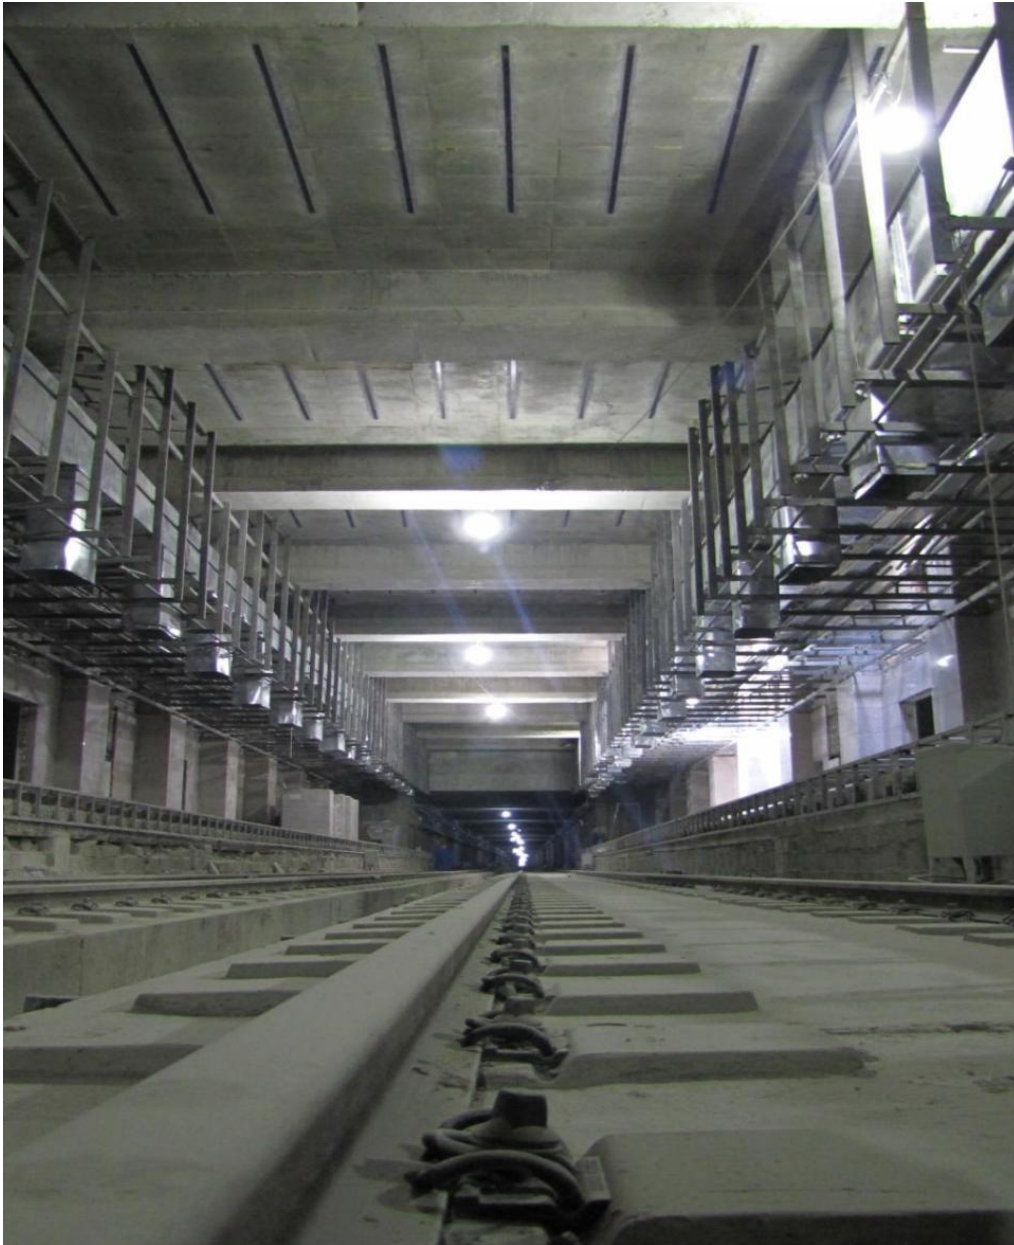
A beautiful view: CFRP Carbon Fiber Stripes are applied under the RC slabs to increase their flexural capacity. Ehsan Station, Shiraz Metro, Shiraz, Iran

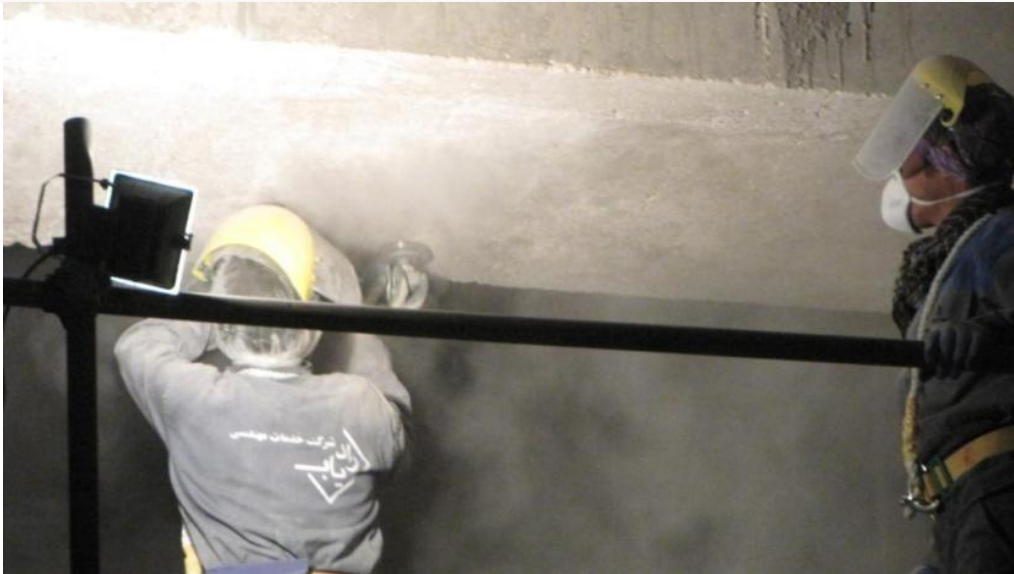
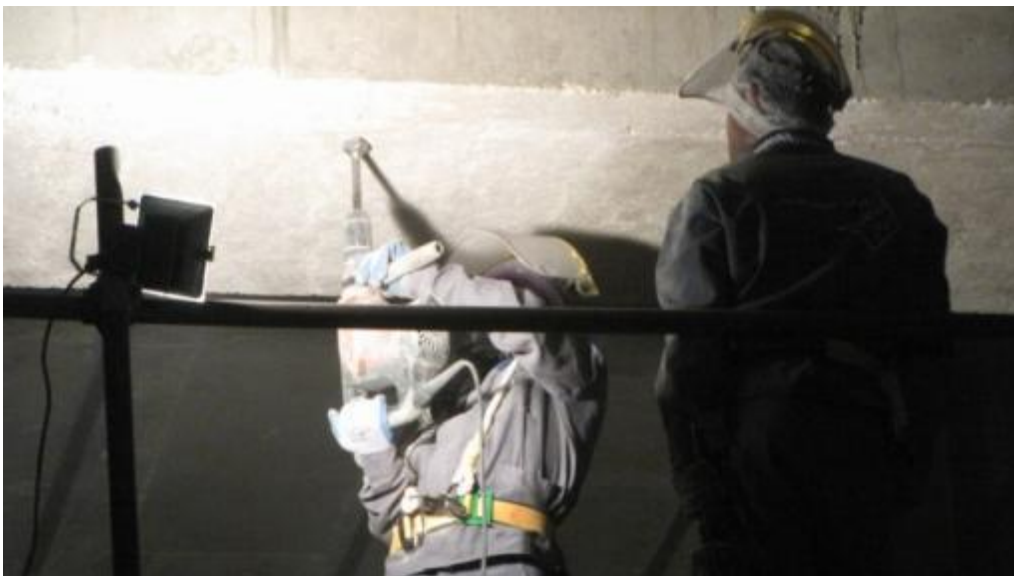
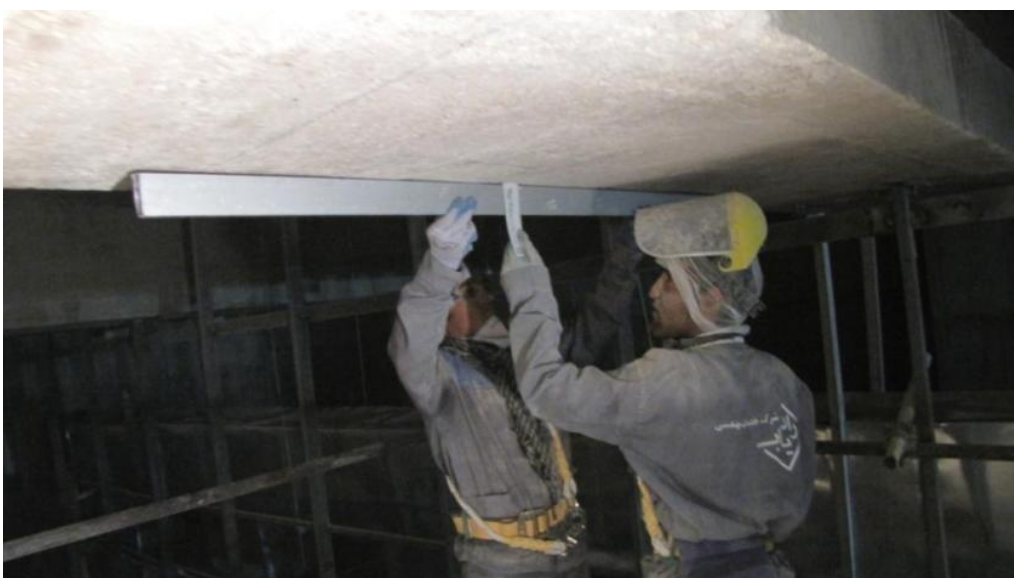
**Grinding the concrete beam surface and substrate preparation before applying the CFRP Strips.
Ehsan Station, Shiraz Metro, Shiraz, Iran**

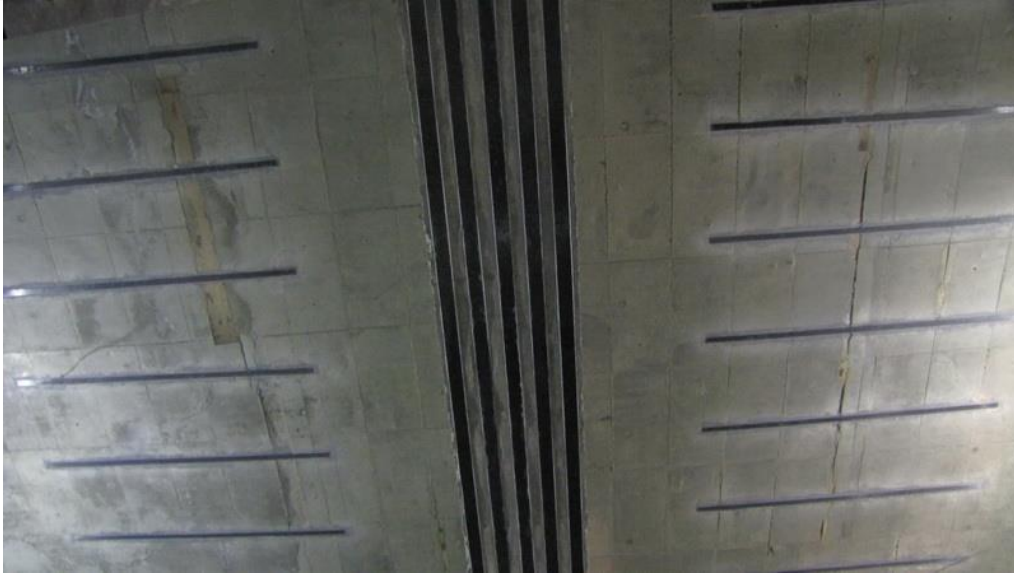
The main beams are strengthened by means of 5 high modulus Carbon Fiber Laminates of 10 Cm width and 1.4 mm thickness. Ehsan Station, Shiraz Metro, Shiraz, Iran

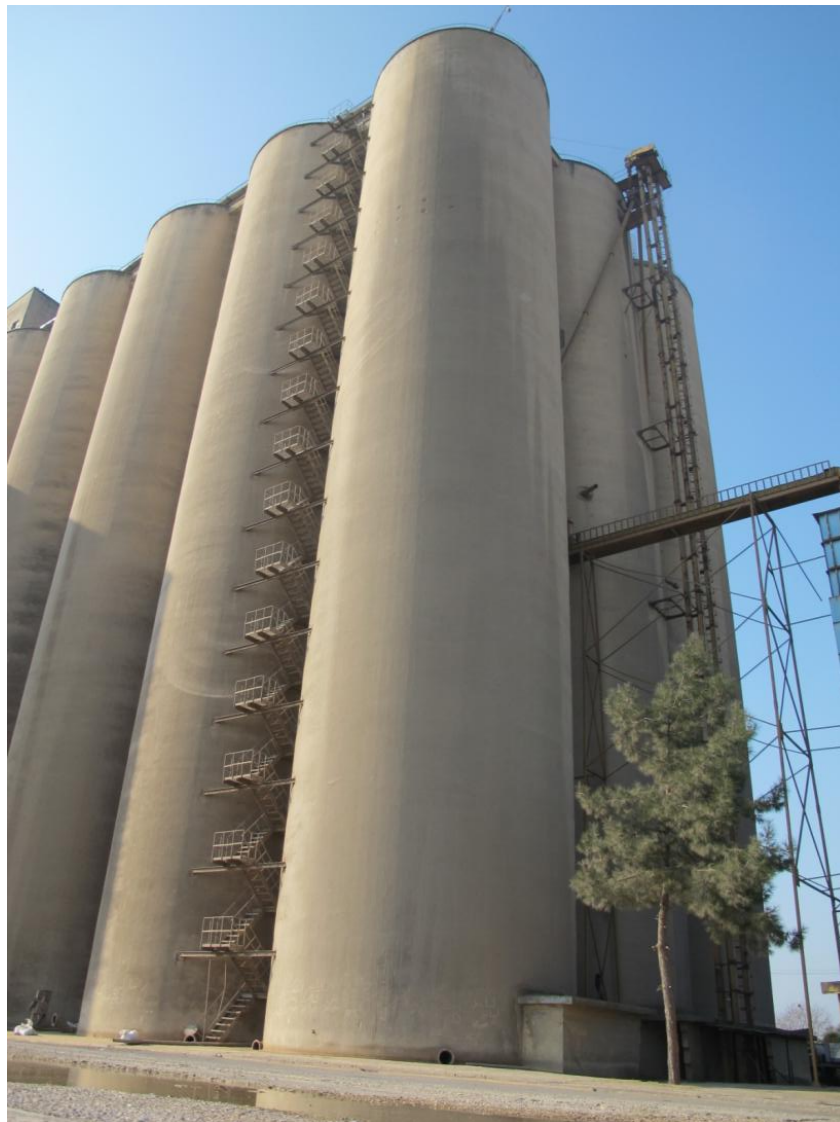
Neka wheat silos have been running for more than 30 years. Local damages and wide cracks have appeared in the concrete during recent years. In some places the cracks were very deep allowing water to leak inside the silo.

Neka Wheat Silos consisting of 33 concrete silos of 50 meter height, Neka, Iran 2012

For retrofitting this structure, damaged concrete was removed, concrete surface was prepared by grinding, CFRP Laminates were applied along the crack length to compensate for the corroded steel bars, CFRP sheets were applied perpendicular to the crack direction to create integrity in the structure and the repaired area was then covered by paint.

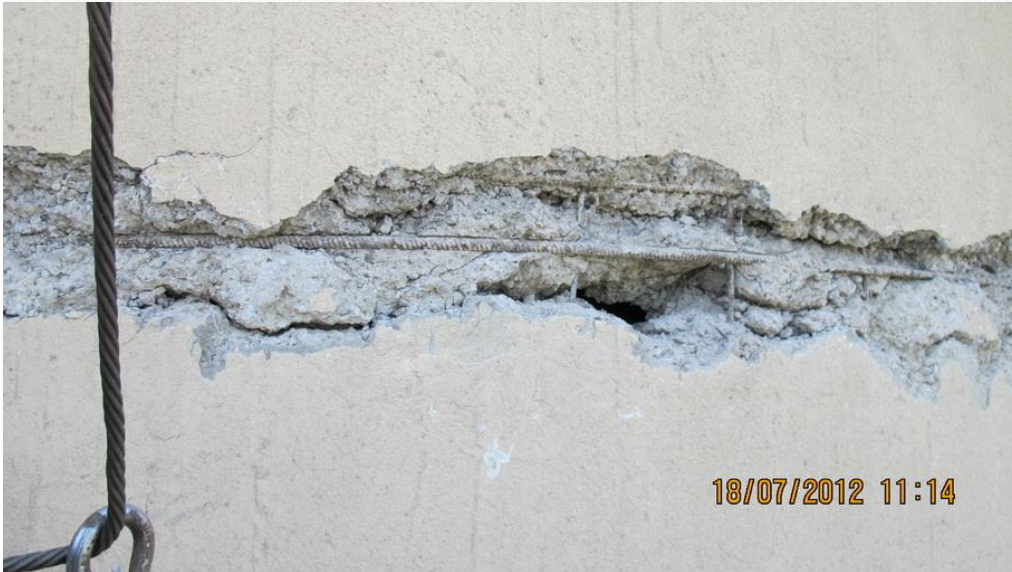
Horizontal crack is so deep to let rain fall penetrate inside the silo.

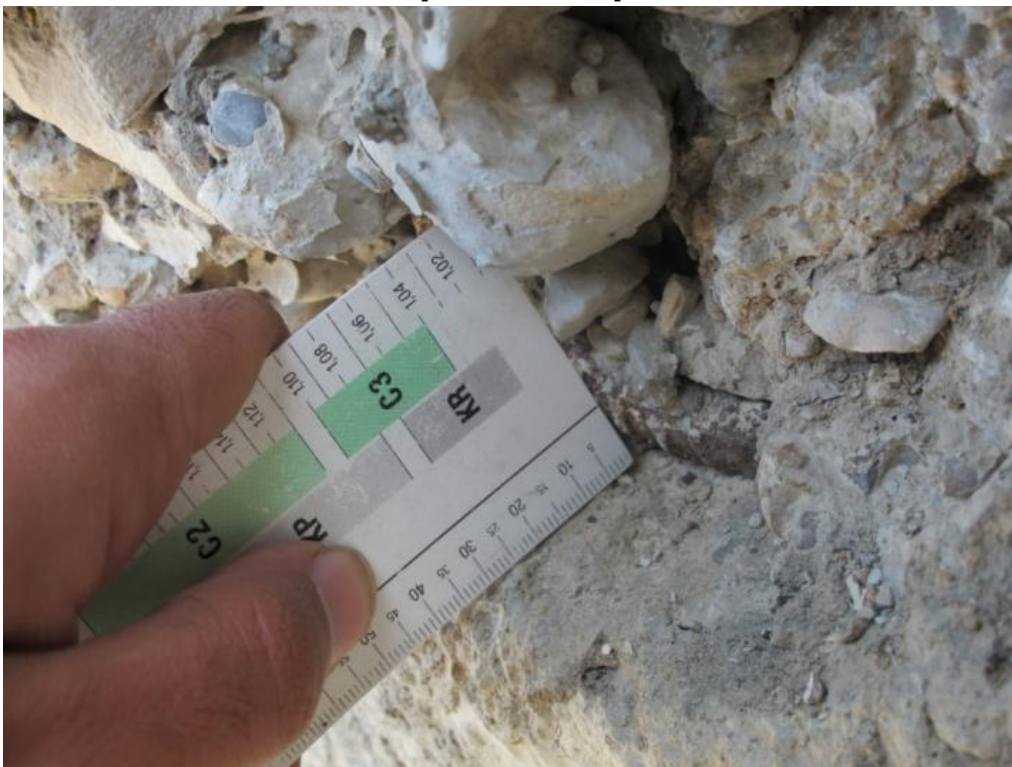
Close view of the crack shows depth of the crack and its porosity.

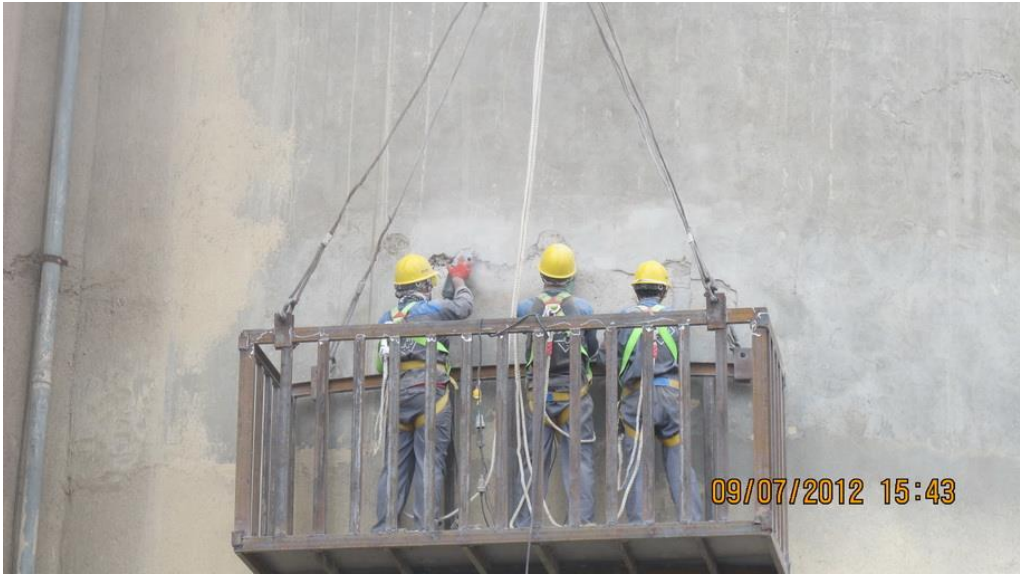
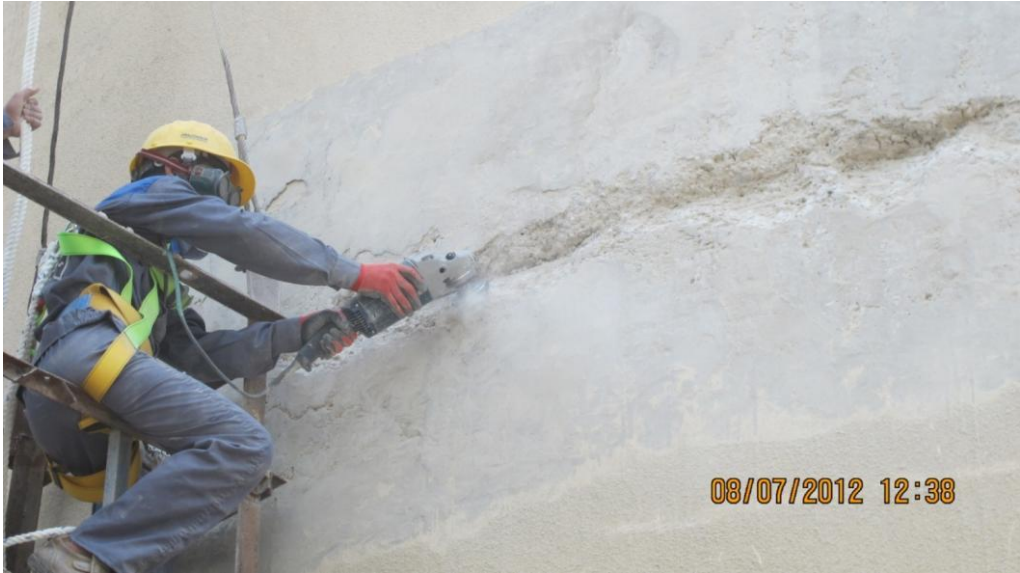
Above Pictures: Radyab Co. personnel are repairing the concrete substrate by means of grinding before the application of CFRP fabrics.

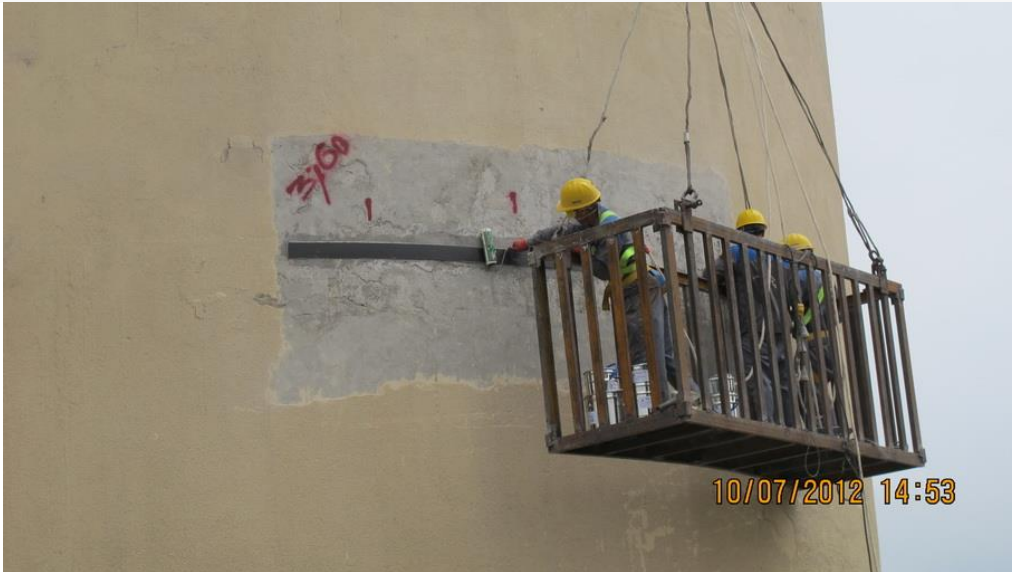
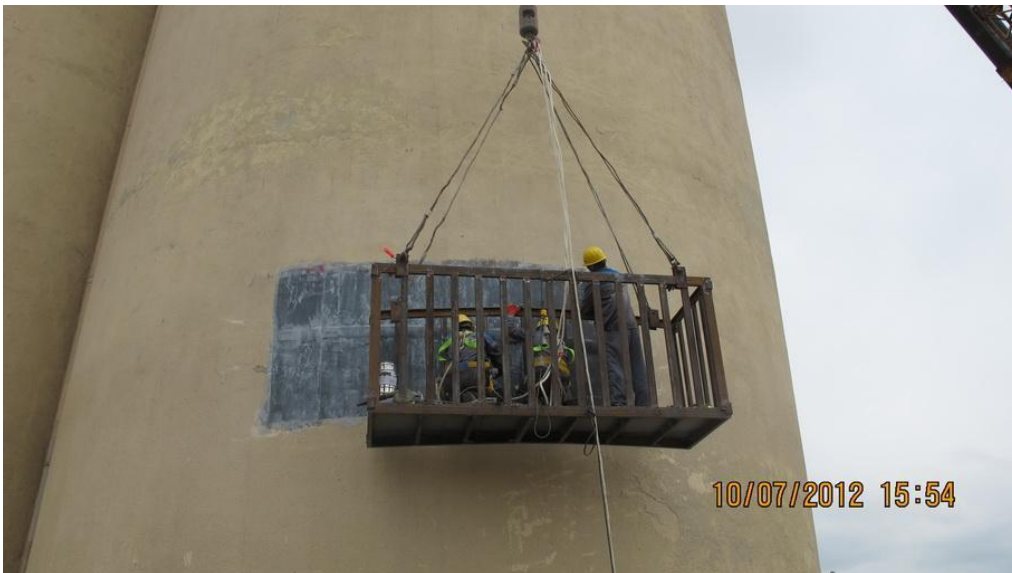
Radyab Co. personnel are repairing the horizontal cracks and replacing the corroded rebars with carbon fiber stripes (FRP). At the end, there is a carbon fiber fabric installed on repair area to maintain structural vertical consistency.

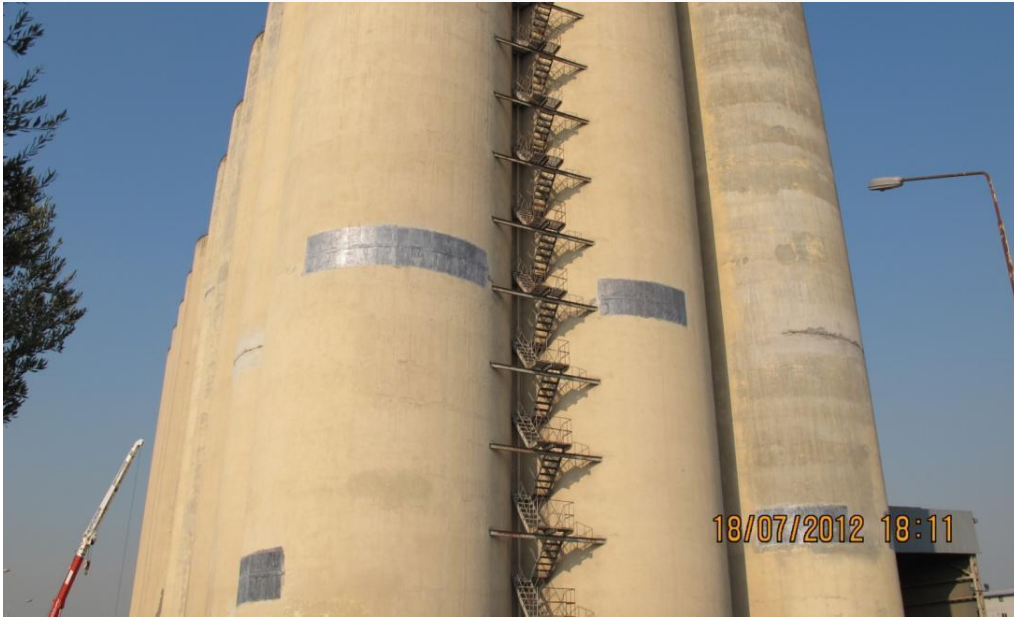
Four horizontal cracks are repaired and strengthened. Two others are opened and grinded before being repaired.

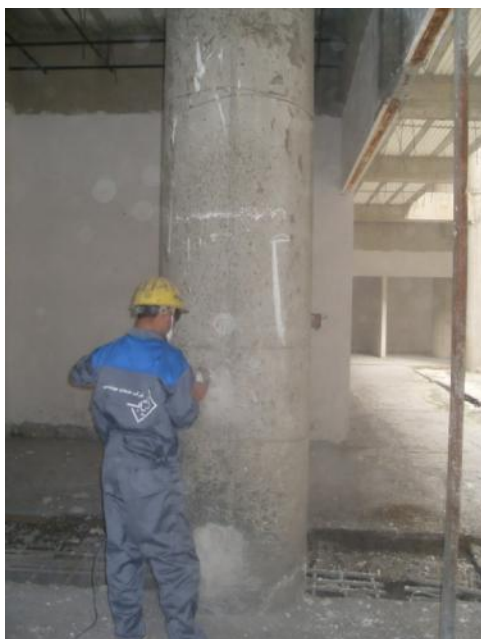
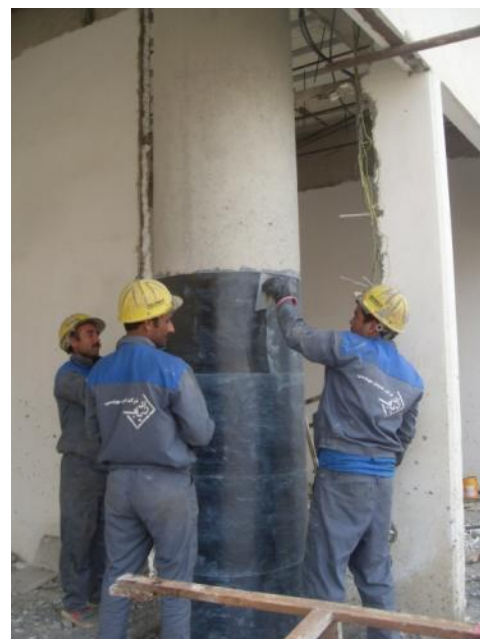
Radyab Co. personnel are grinding and then wrapping the columns with FRP composites.

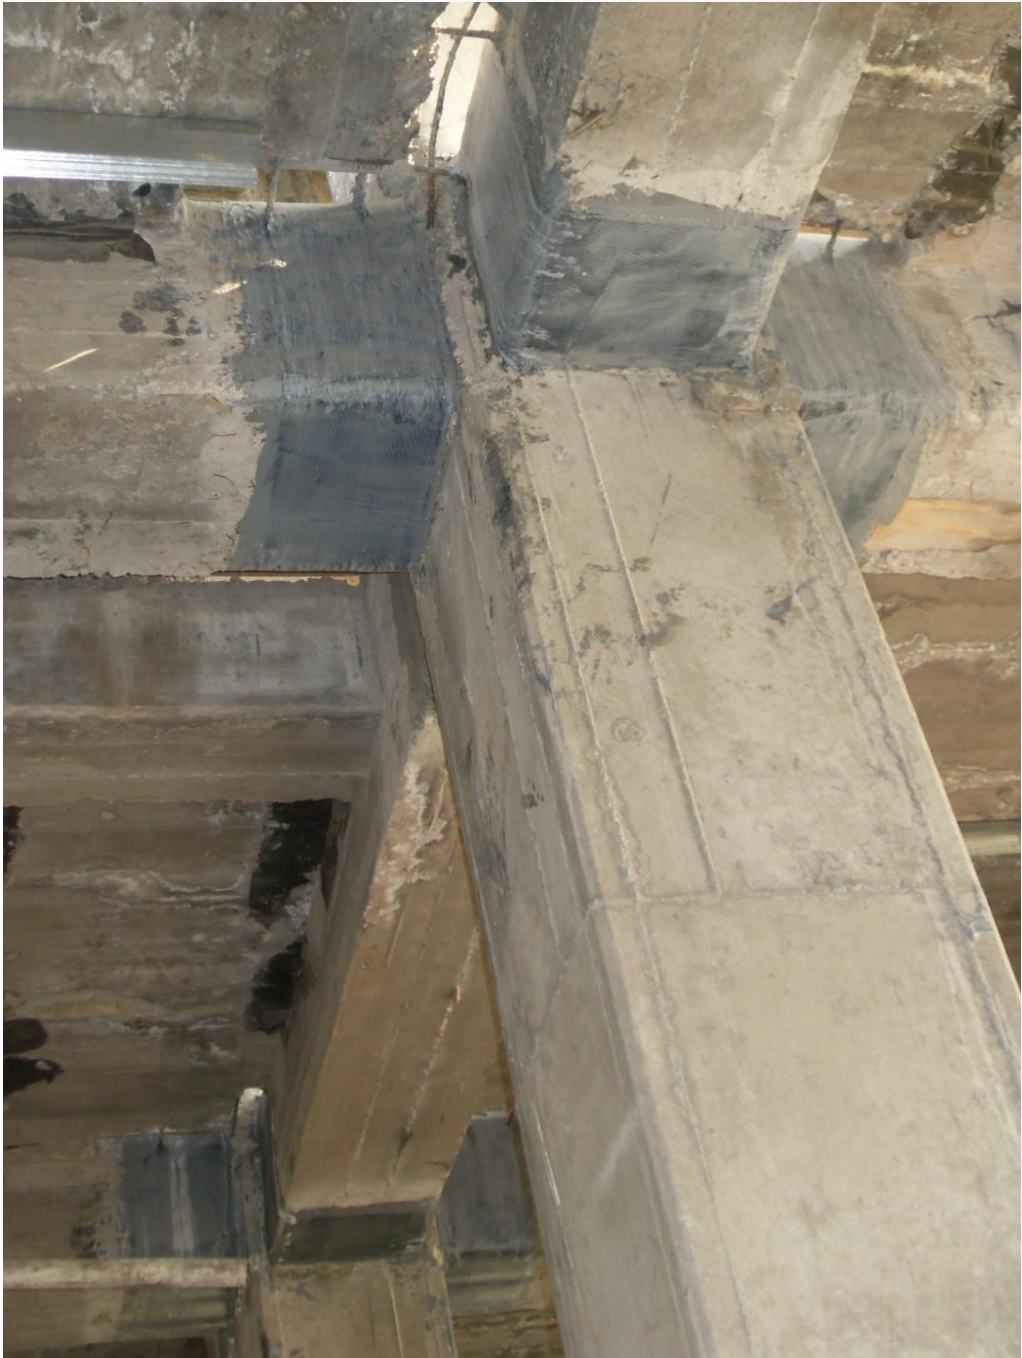
Beams are strengthened for shear at the ends (supports).

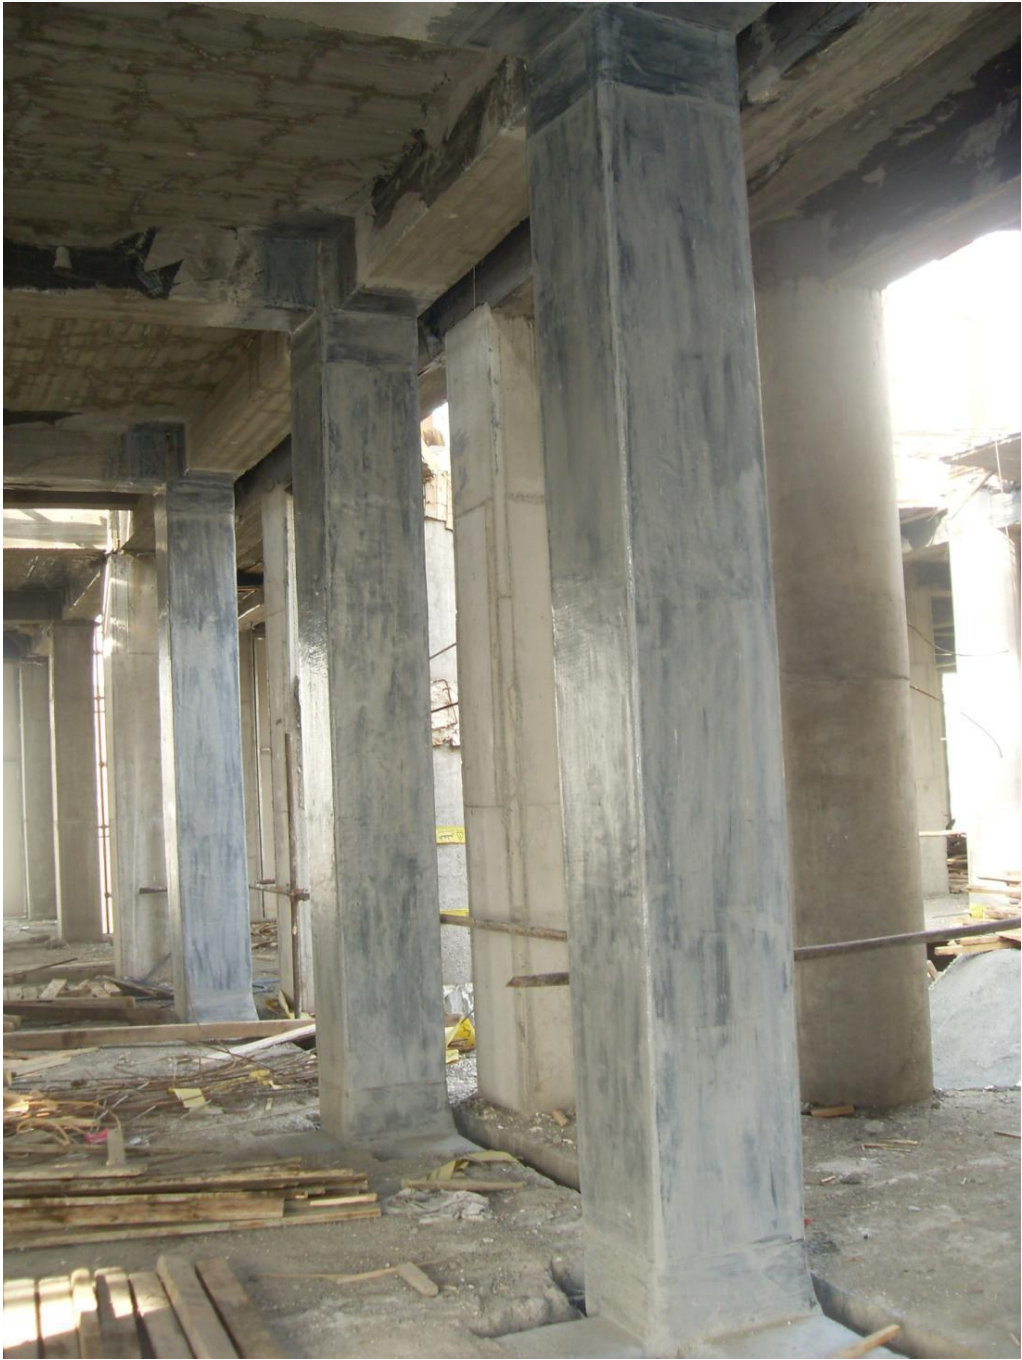
Columns are strengthened for bending at their overall length.

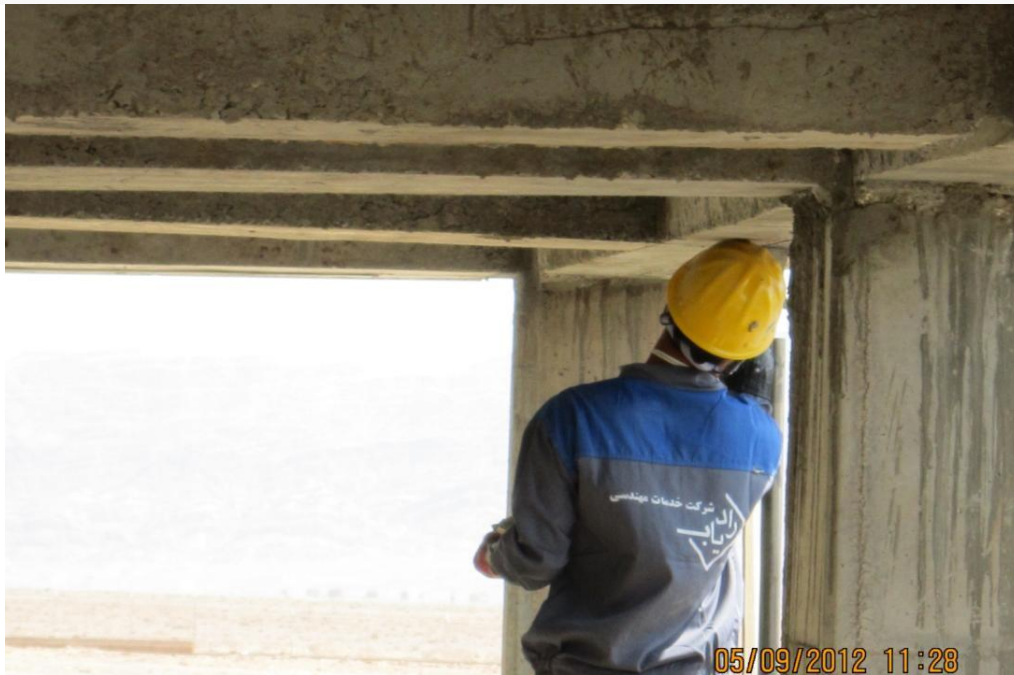
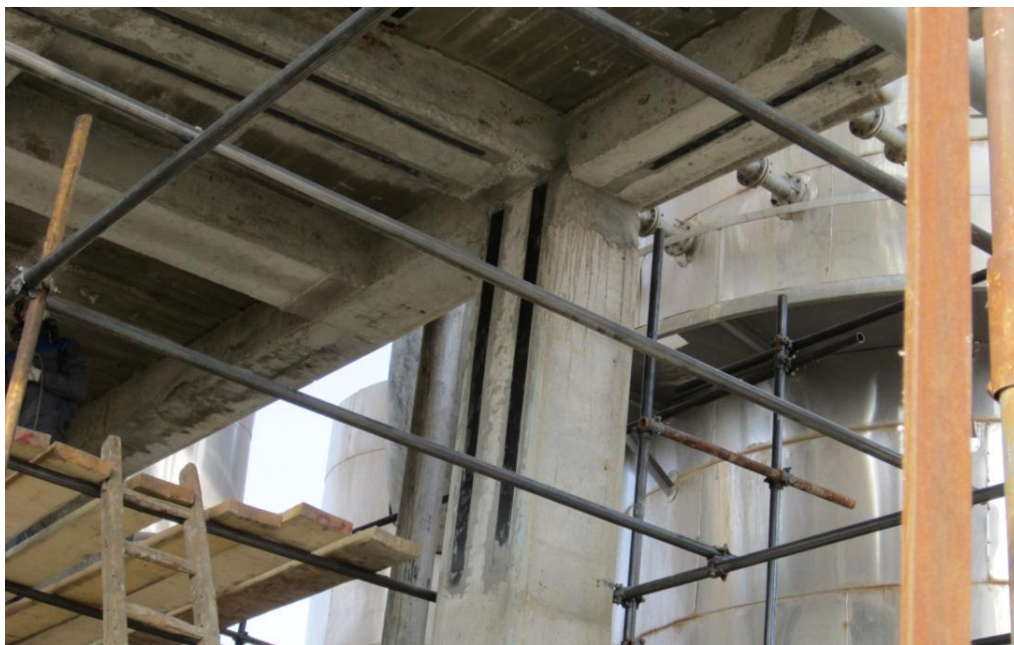
Above Pictures: Installation of carbon fiber stripes on the RC beams and columns in Kimiadaran plant to upgrade load capacity of the structure.

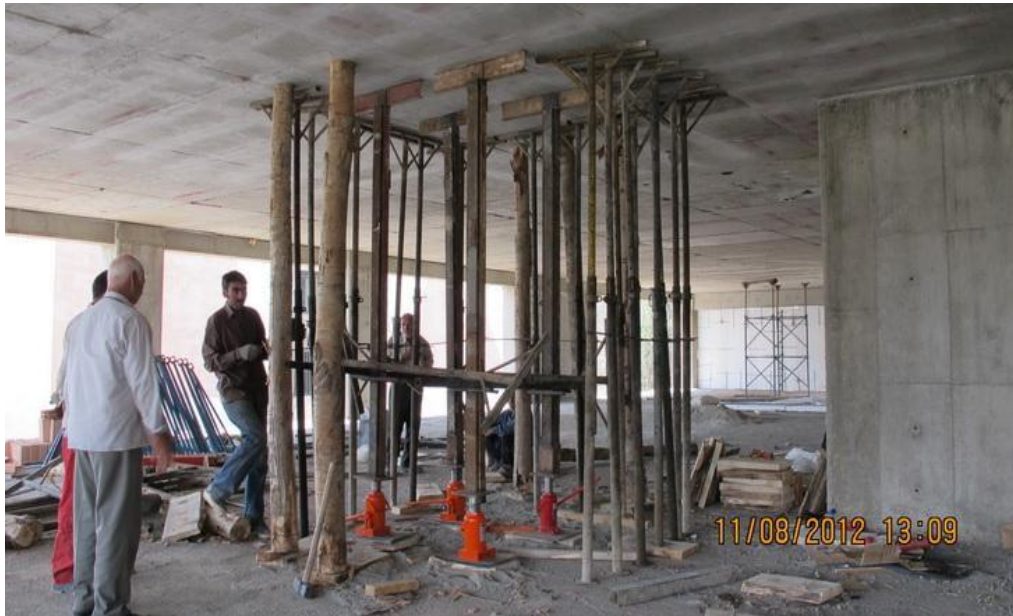
Ashrafi office building contractor encountered problem of deflection in the floor decks during its construction. Carbon fiber strips are applied to control and limit the flexural deflections in both lateral axes.

Floor deck is lifted up to compensate the deflection by means of hydraulic jacks.

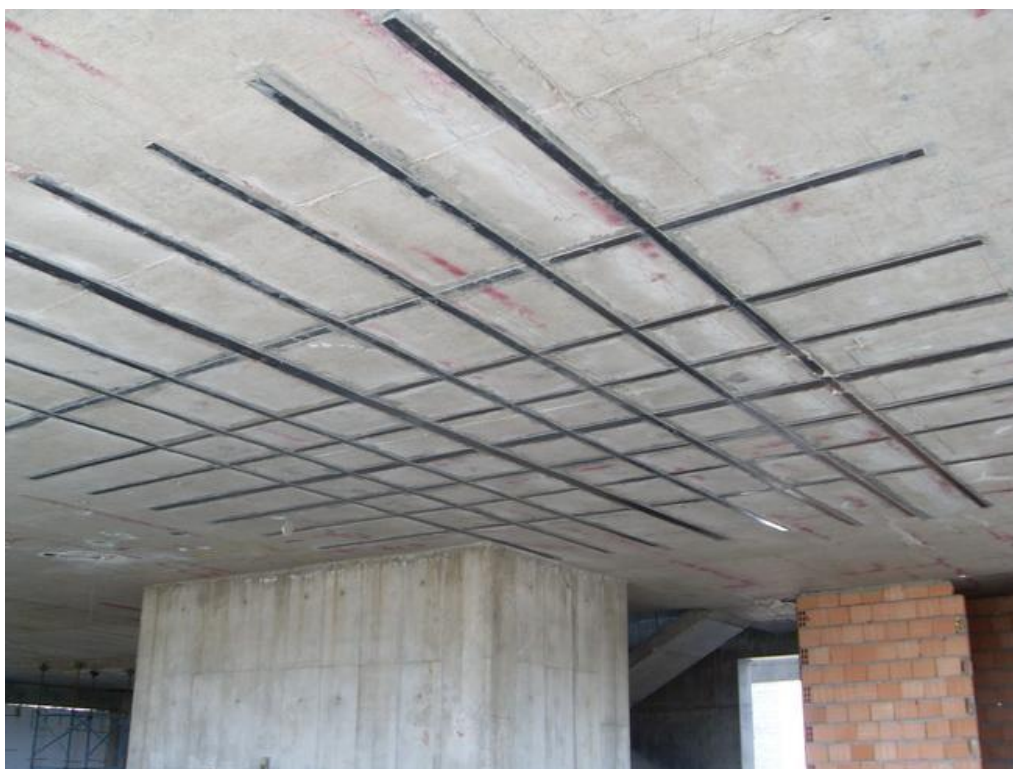
Carbon fiber strips are installed at the bottom side of the deck in X and Y axes.

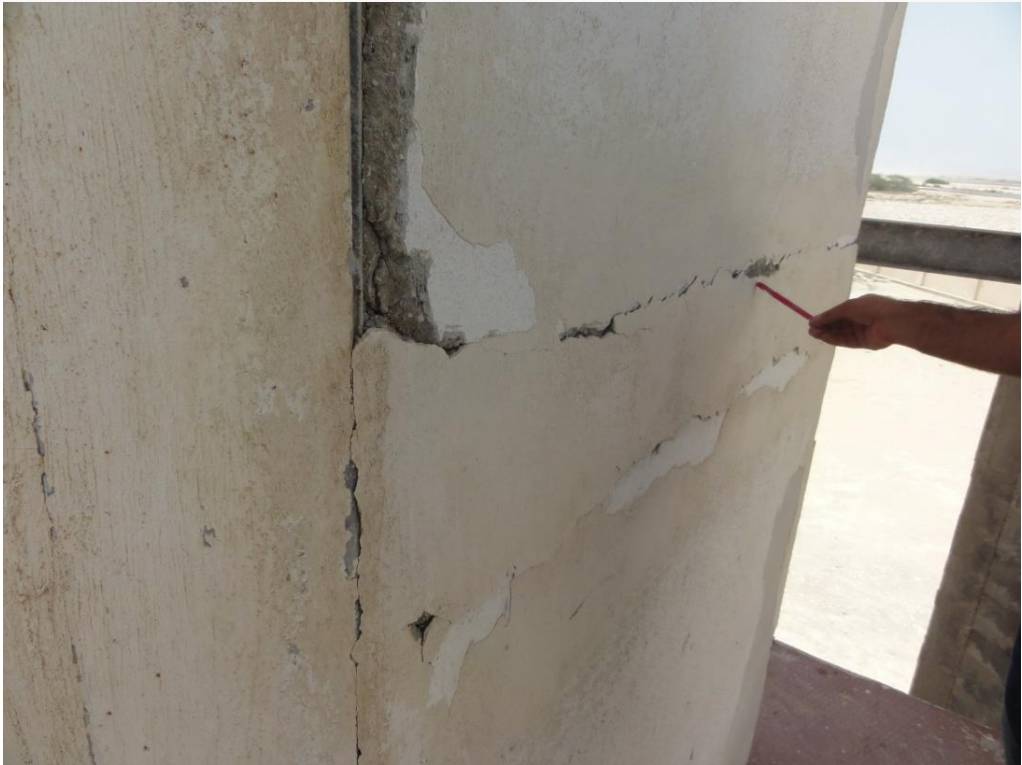
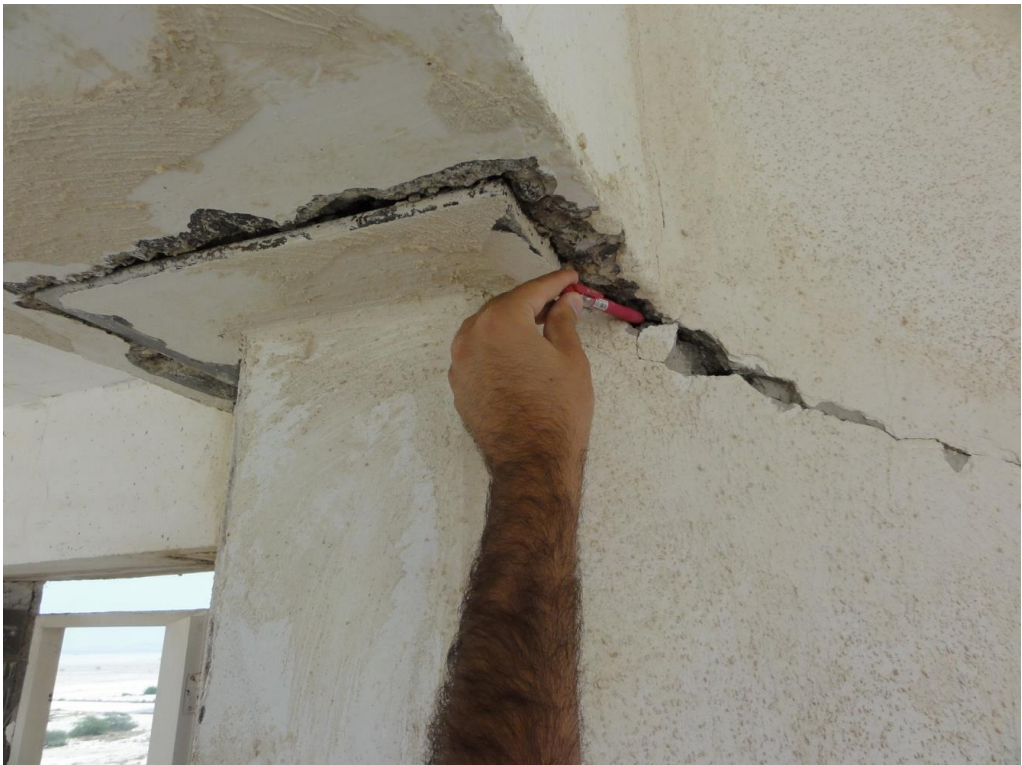
Above Pictures: Damages to the Qeshm International Airport Control Tower due to 2012 earthquake
