RADYAS
Engineered Solutions

Project: Azadi Grand Hotel Tehran, Seismic Rehabilitation Design and Supervision. Tehran, Iran 2004 – 2010

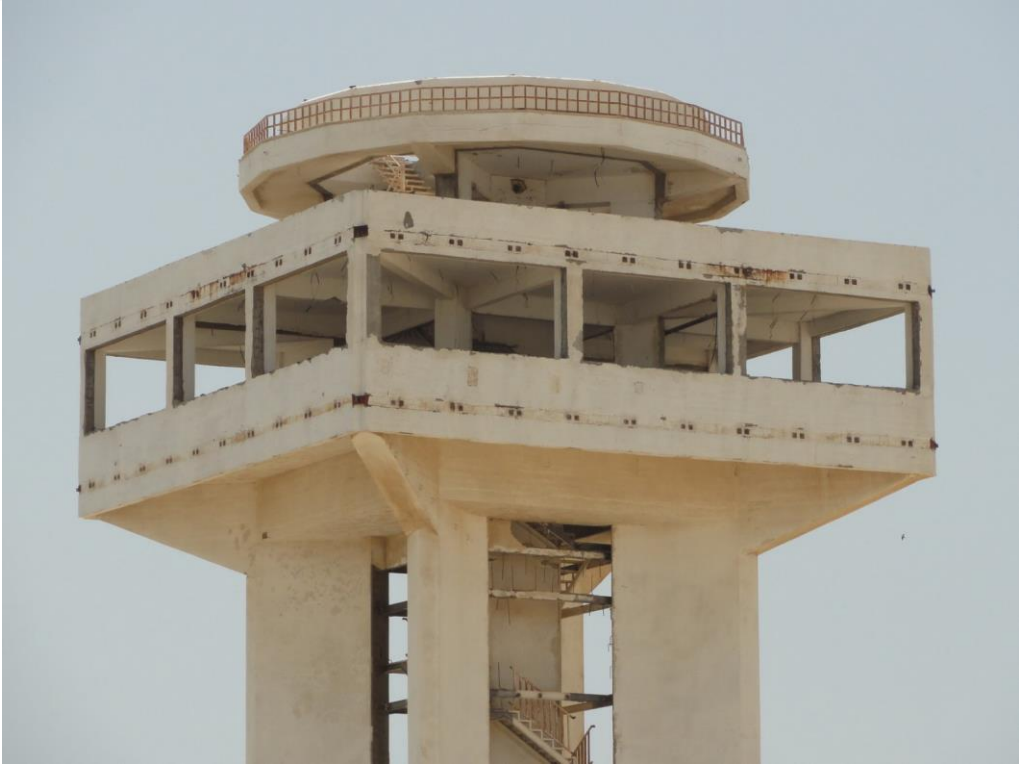
The control room was separated from the main structure due to earthquake
